# I2C Signal propagation on TOB cards Where do we stand

A. Marchioro  
13/7/2003 v.2

I2C bus on TOB

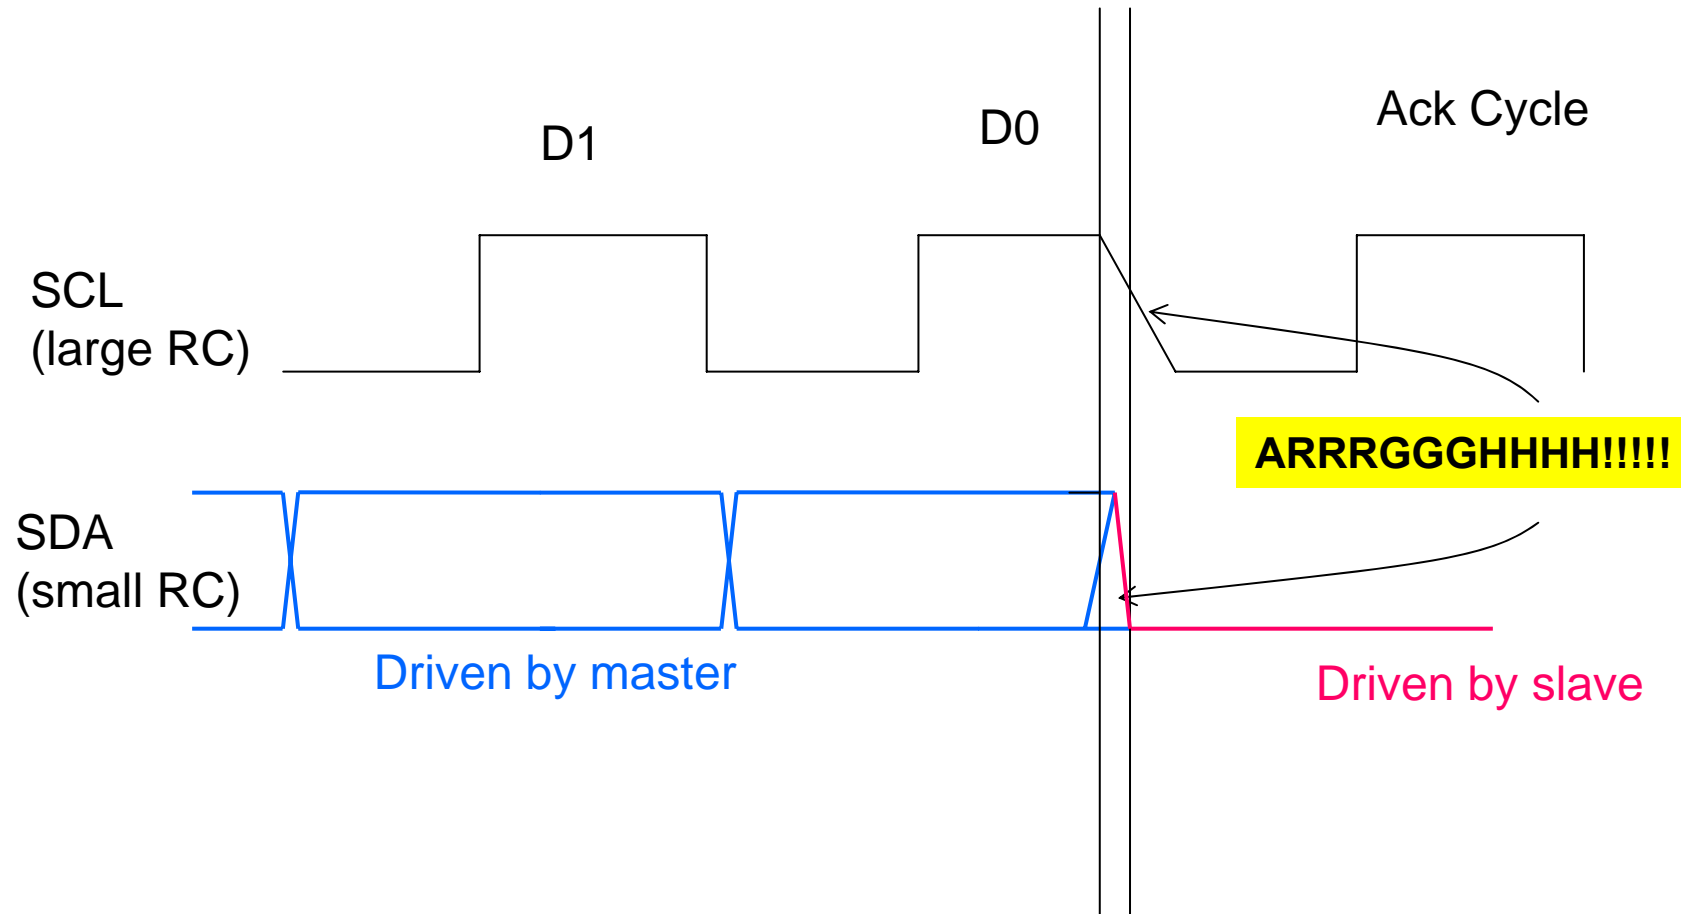
- Occasionally, when accessing sequentially components on the I2C bus (LLD, DCU etc.), the APVs are found not to respond correctly to I2C commands
- This can data pattern dependent (as the last bit of the data sequence is the one most often misinterpreted)

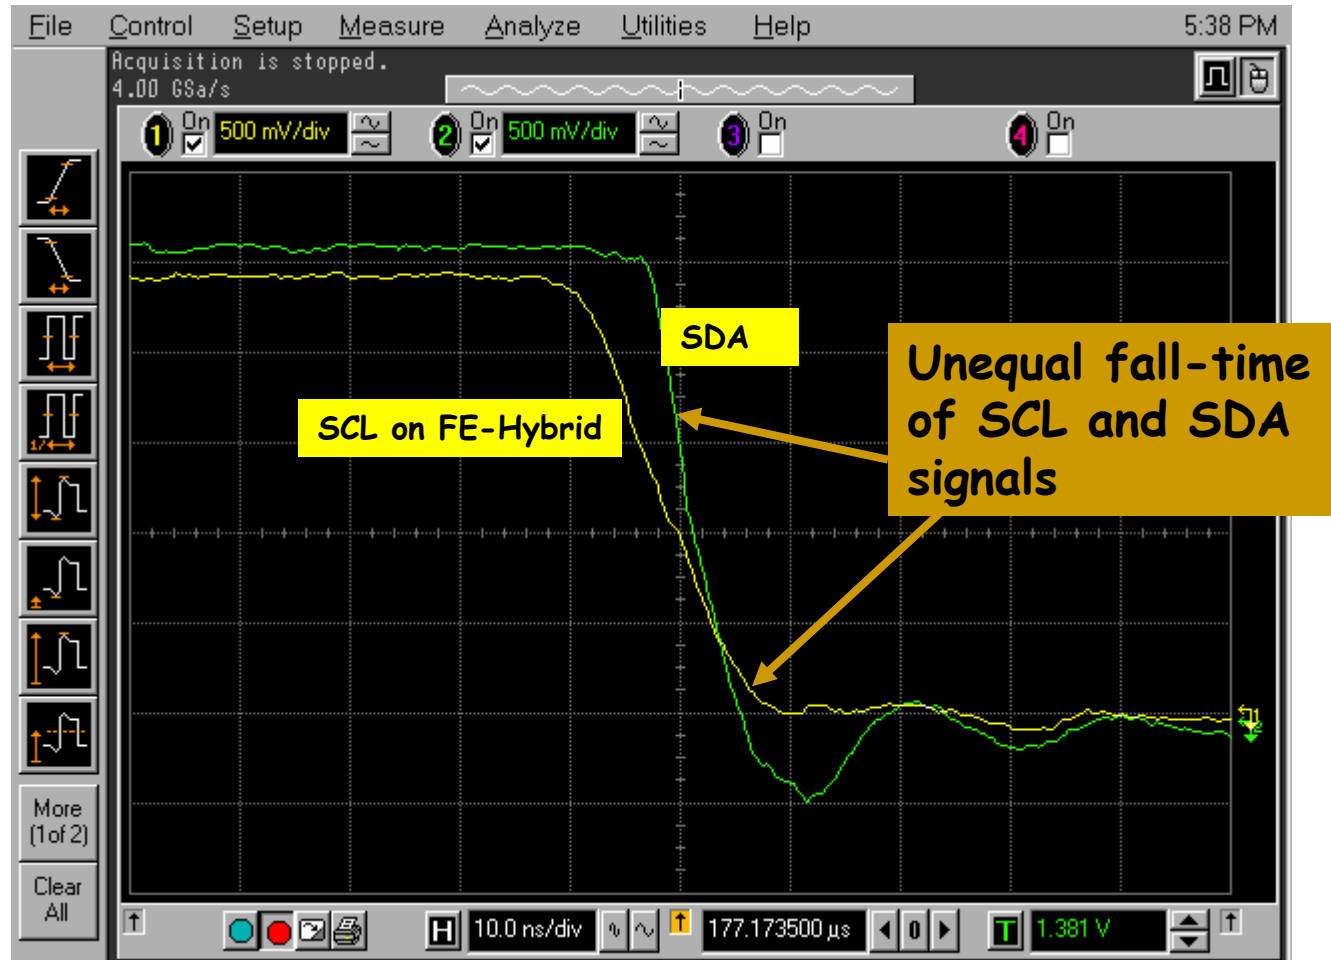
Picture shows sequence of SCL/SDA signals with SDA pulled-down in AOH and measured on FEH

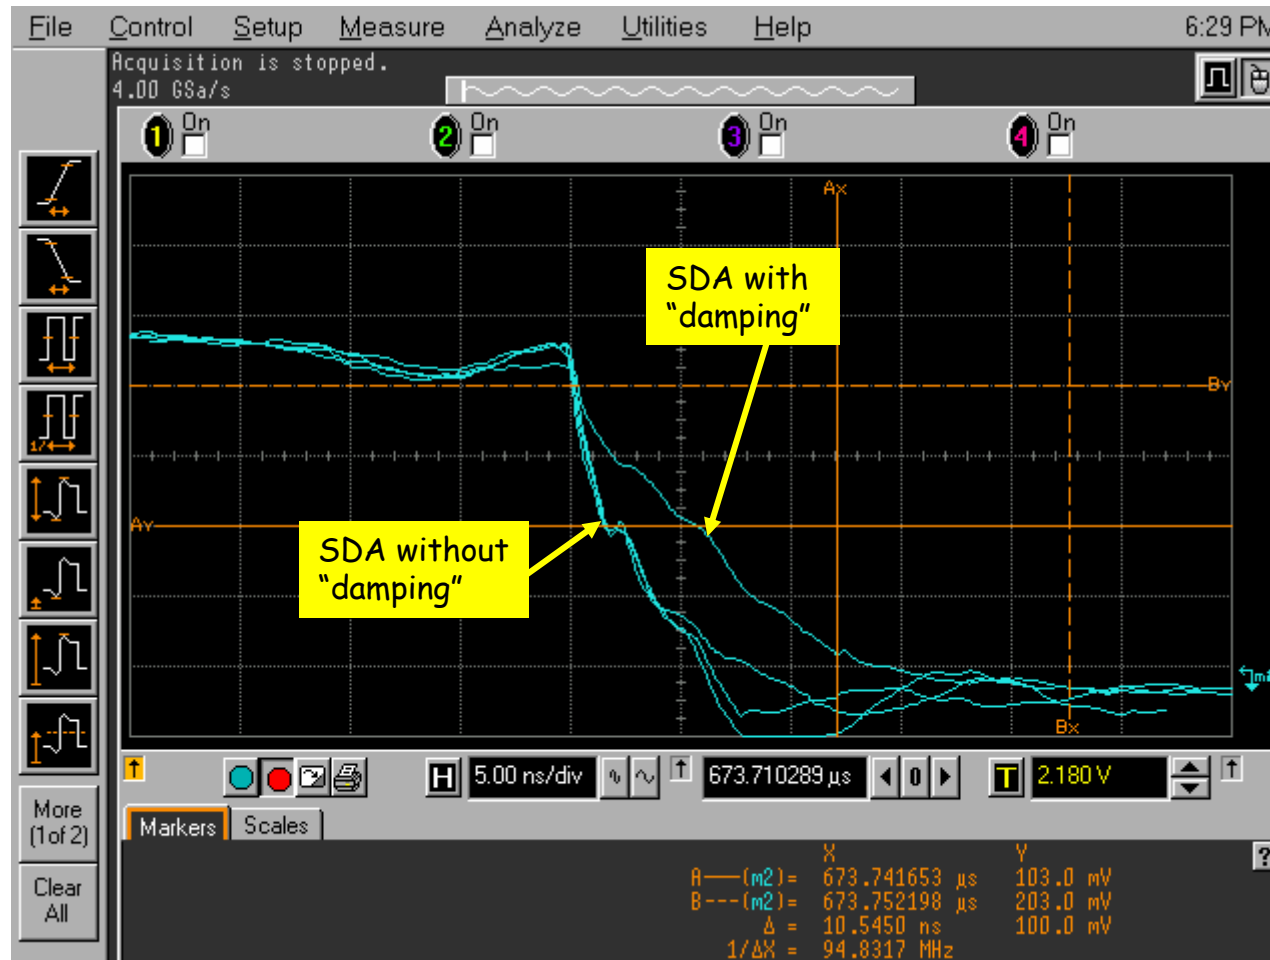
# Effect of "damping" resistor

SCL not show on this slide

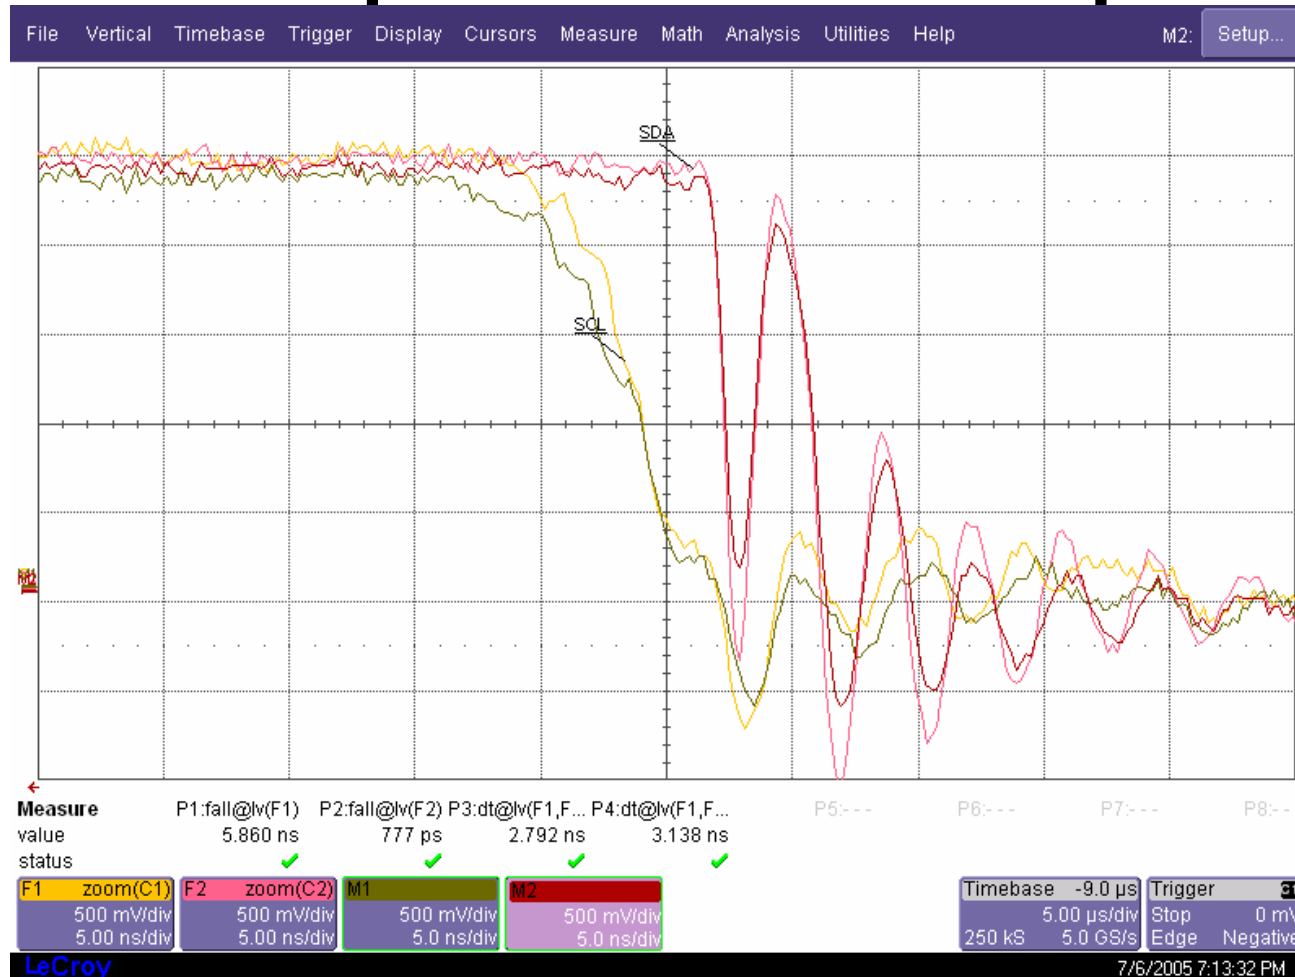
# Temperature comparison (1)

Process variation	All chips produced in same batch, very small variation
Temperature	Very noticeable (see following slides)
Irradiation damage	Measured effect is only 5-8 %

Pos. 42 LDD response measured  
on the AOH at -23°C and at RT  
W. Karpinski-Aachen 14

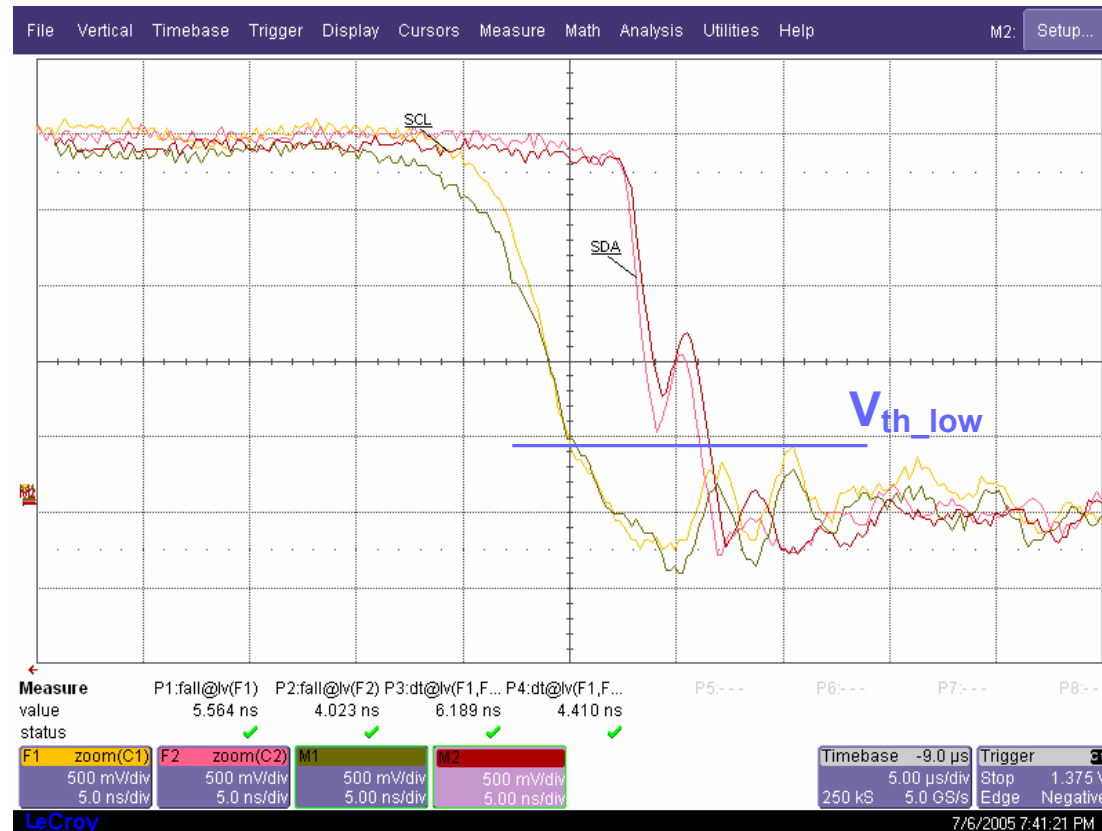
# Temperature comparison (2)

Pos. 42 LDD response measured on the  
FEH at  $-23^{\circ}\text{C}$  and at RTW.  
Karpinski-Aachen
