Analysis on TEC Expressline II modules

- Two different topics:
- Strip defects (3 modules)
 - Global IV (2 modules)

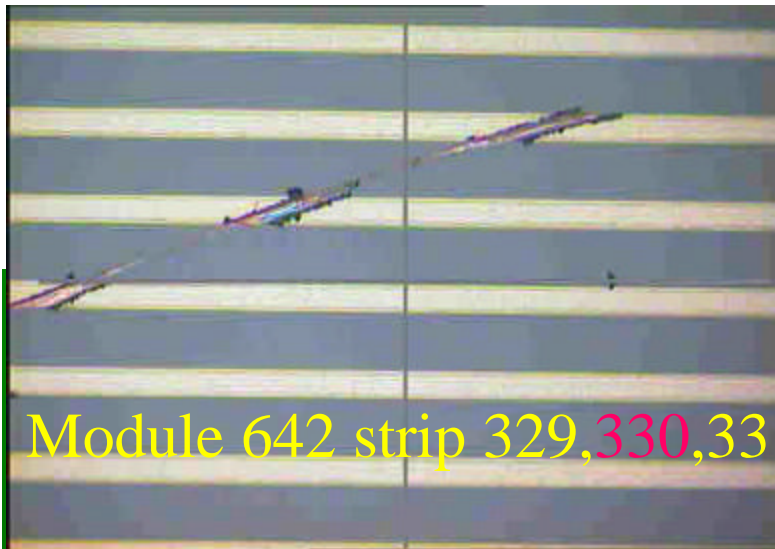
Scratches: sensor defects (mod 642)

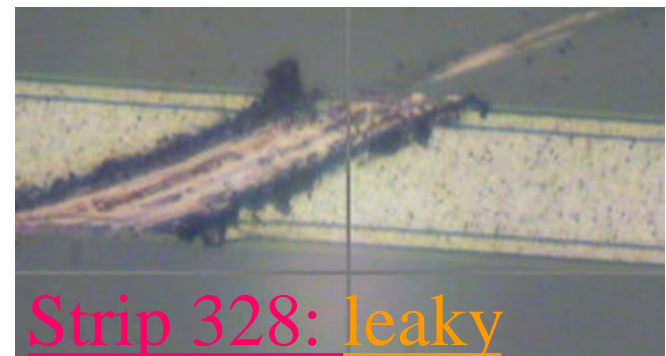
Module 642 strip 329,330,331

Strip 328: leaky

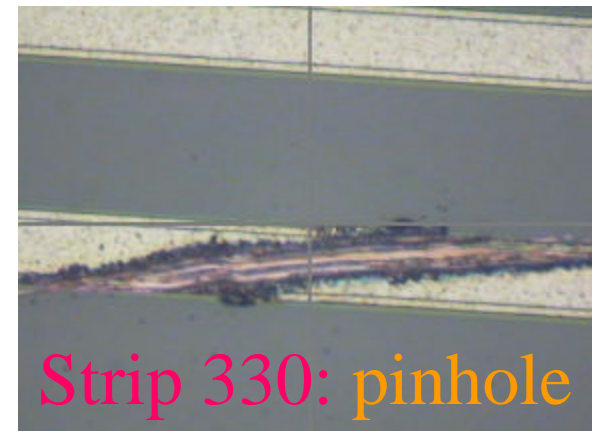
Strip 330: pinhole

1 Scratch from strip 327 to 331 produced **2** different defects!

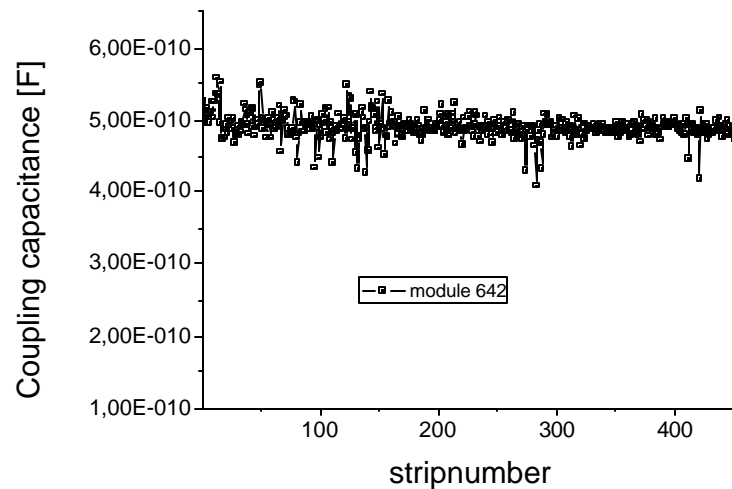
Module 642 -- strip scan on module

Coupling capacitances: all in specs
Overflow @ strip 330 → pinhole

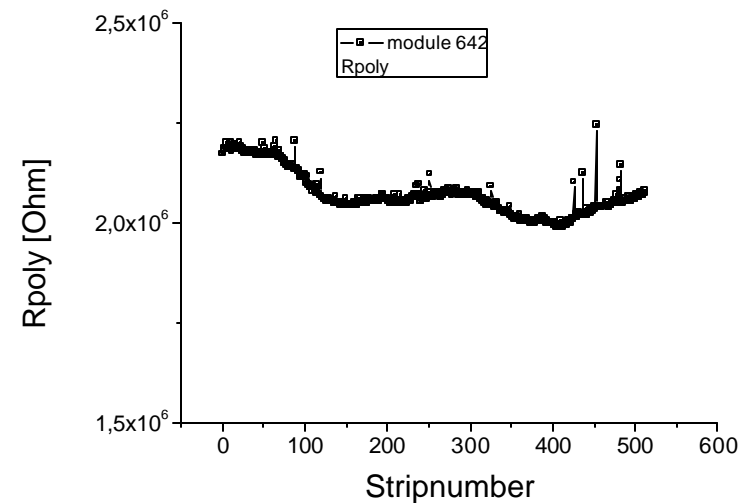
Rpoly: all in specs

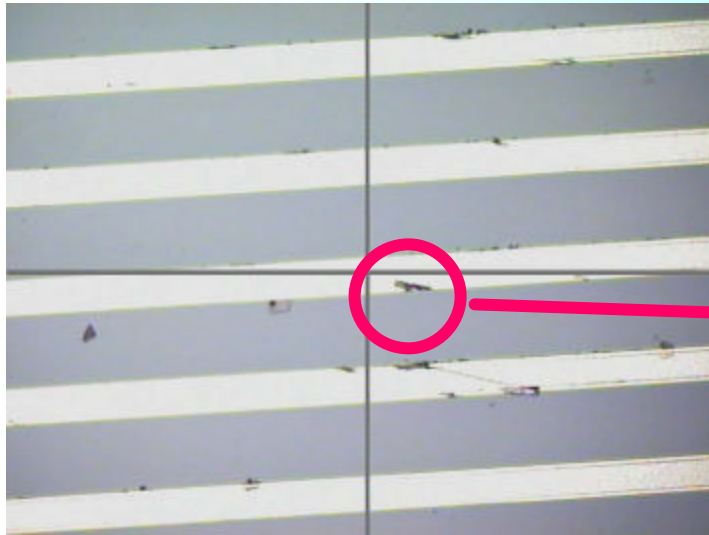
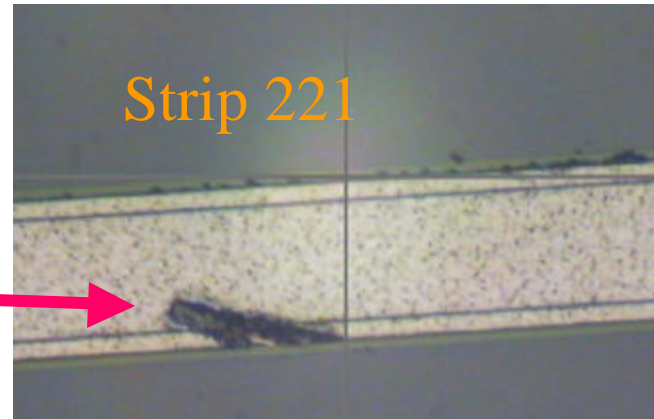
Mod 643 add pinholes between DEC02 to JAN03

This happened somewhere
after the first module tests!

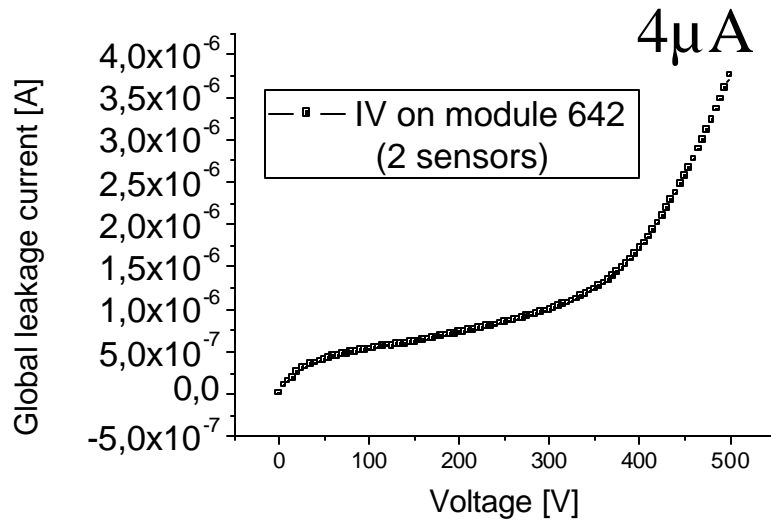
Module 642

High IV + early soft breakdown

Slight but **non-critical**

increase in IV!

Compare to the 40 μ A limit!

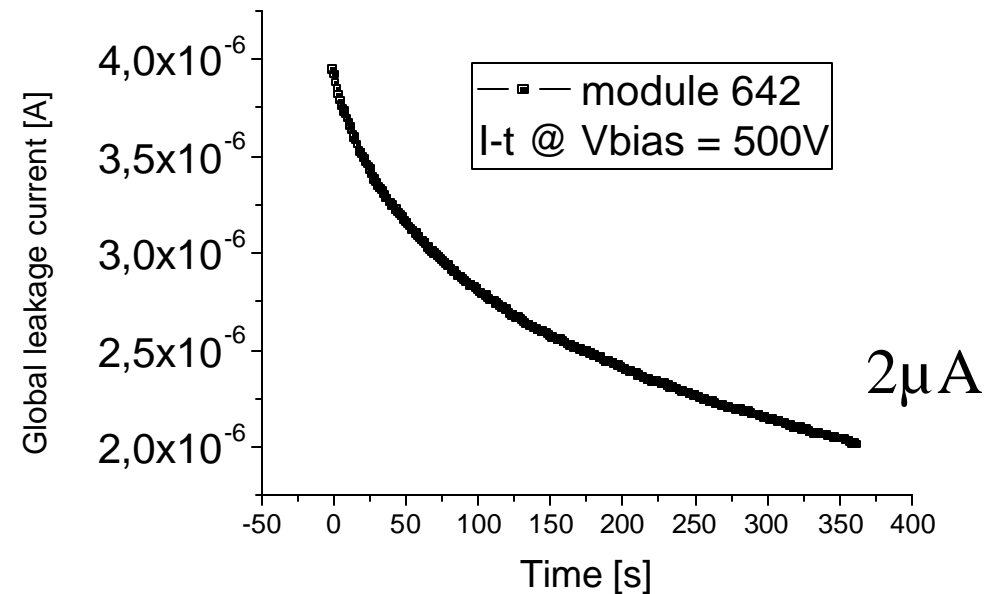
Initial current decrease with time!

Known IV behaviour of sensors!

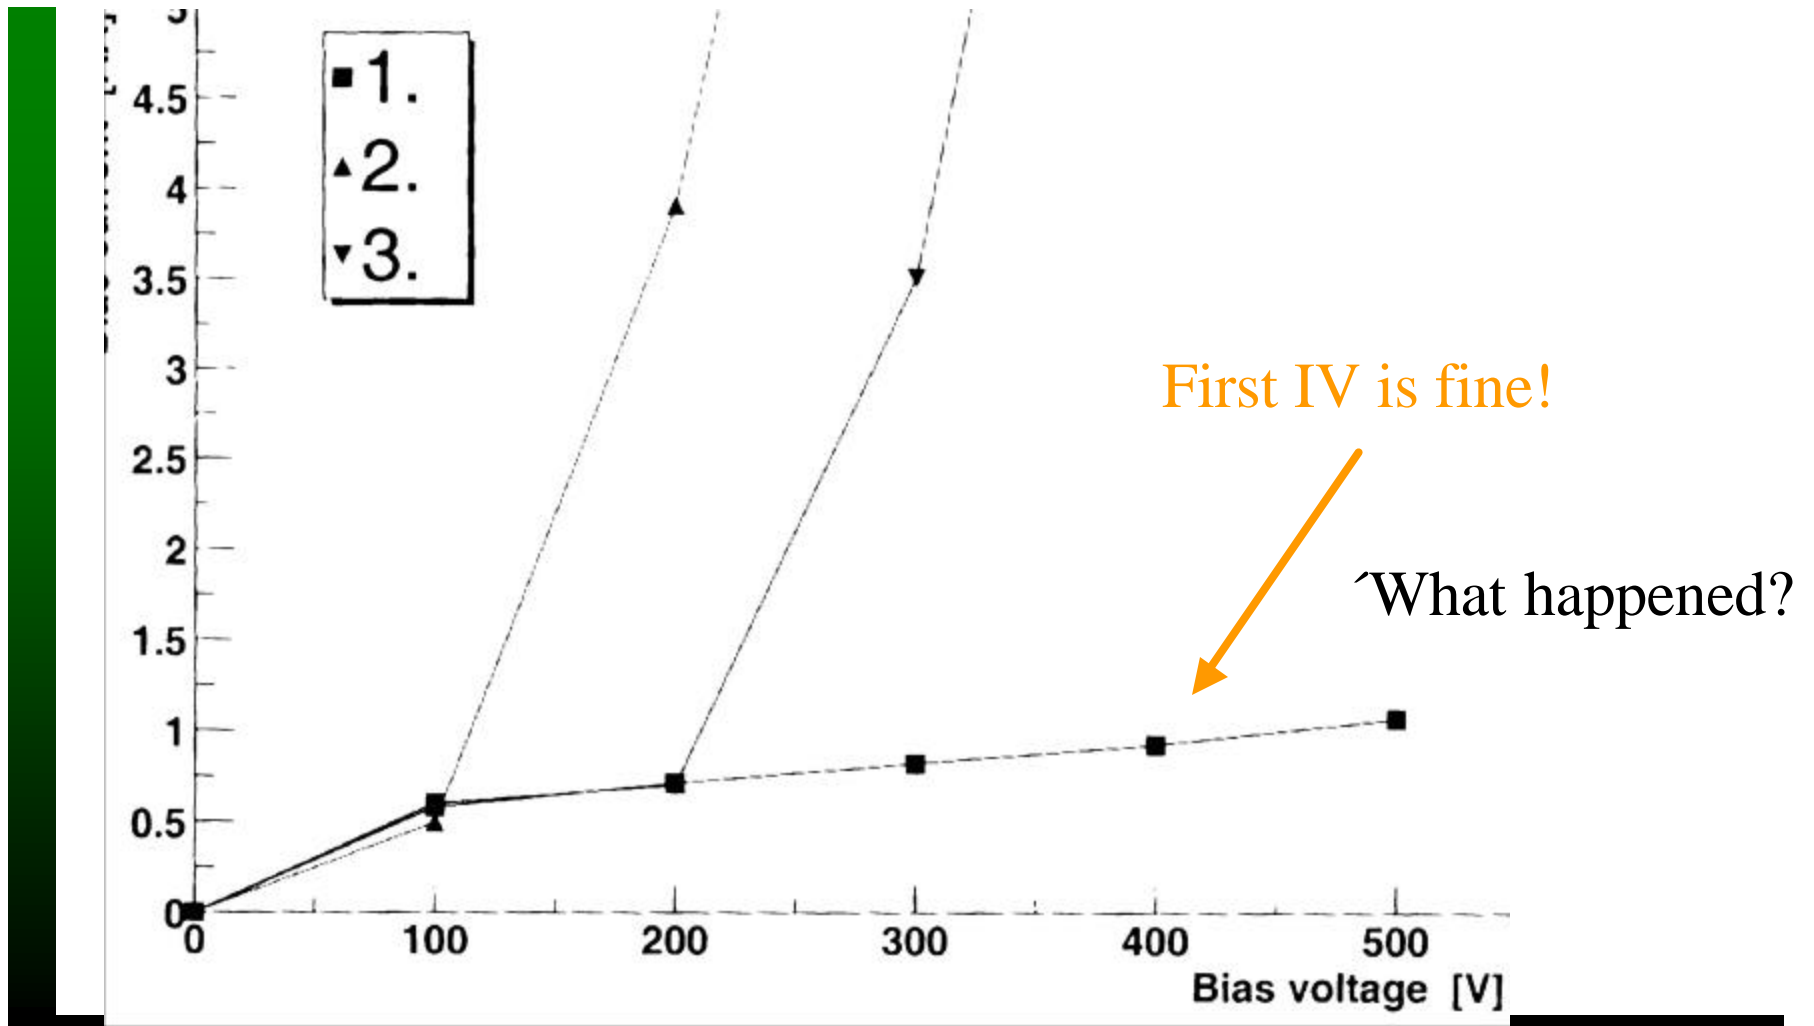
Mod 643

High IV + early soft breakdown

IV reported by Aachen

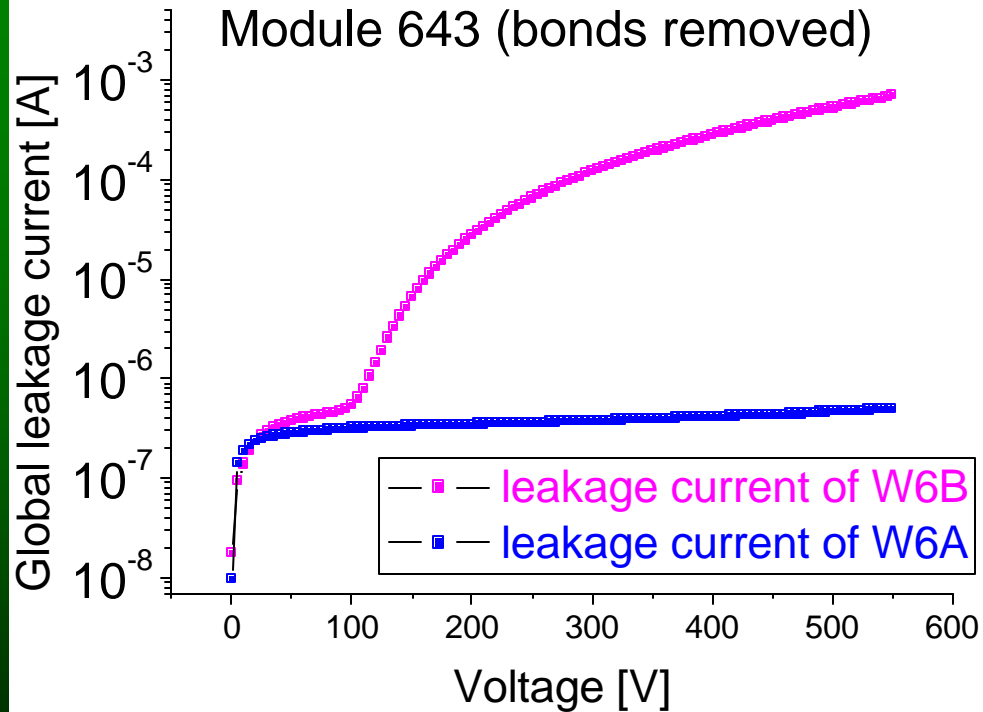
IV on module 643

- IV on W6A is ok, IV on W6B shows early breakdown as full module!
- Cleaning improved the current but did not solve the problem:
 - A) Isoprop, B) isoprob plus tissue, (C) ultrasonic bath)
- Strip scans (leakage current) on **both** sensors show nominal currents!
- ➔ ➔ IV problem is **NOT** located in the strip region!
- ➔ Remaining defect location: Backside, Guard-, Bias, n++ -region!
- ➔ **Removal of W6B with a scalpel** ➔ **no further increase in IV!**
- ➔ **NO** visible breaks on the backplane (add. inspection on the edges)
- ➔ ➔ Remaining defect location: Guard-, Bias, n++ -region!

→ Closer investigation
on W6B SENSOR

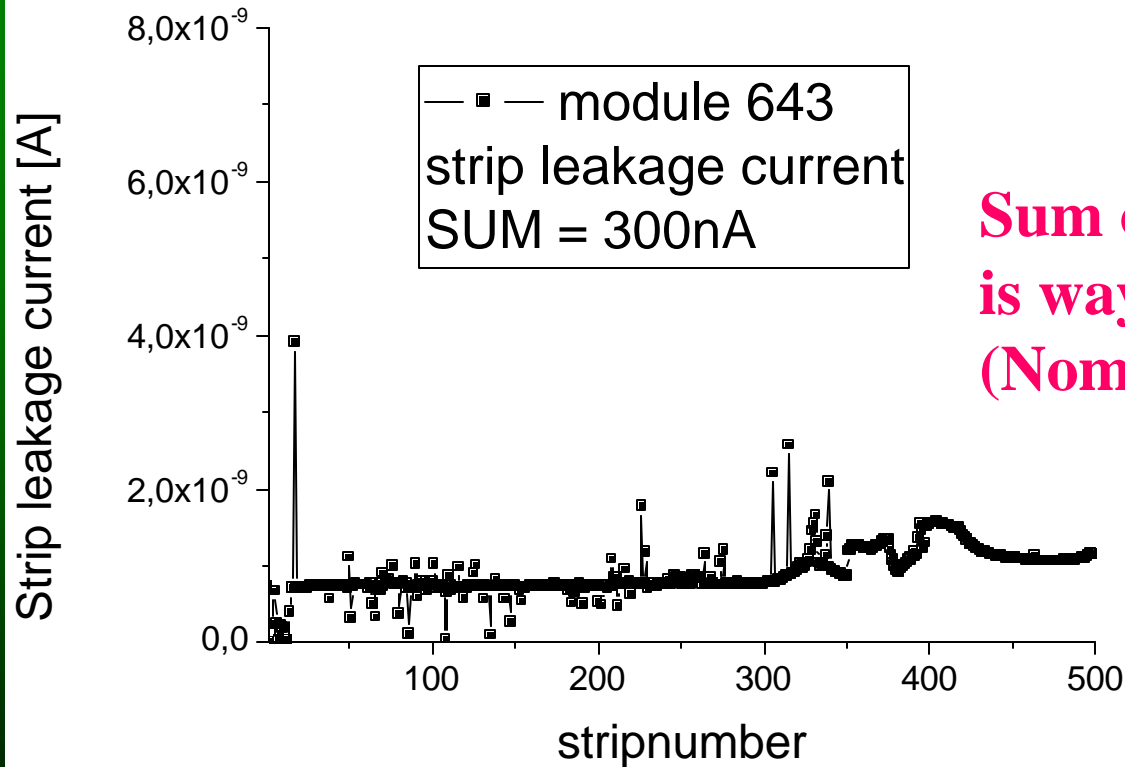
Strip leakage current

**Sum of individual currents
is way below the total current!
(Nominal values)**

Individual strip currents are as expected for HPK (very low)!
Other strip parameters checked for are in specs!

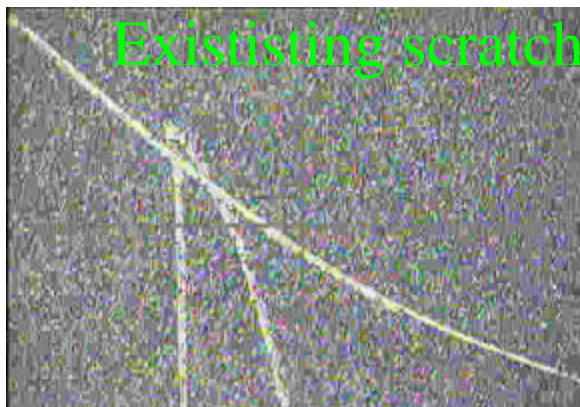
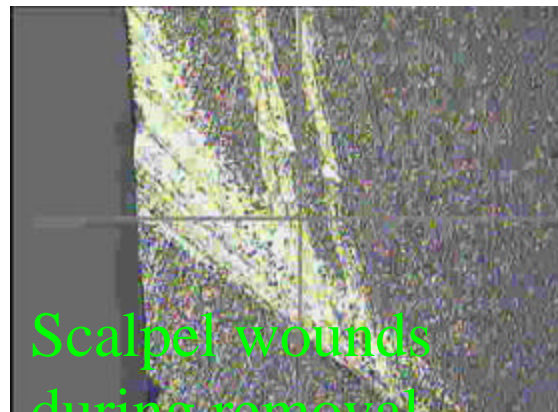
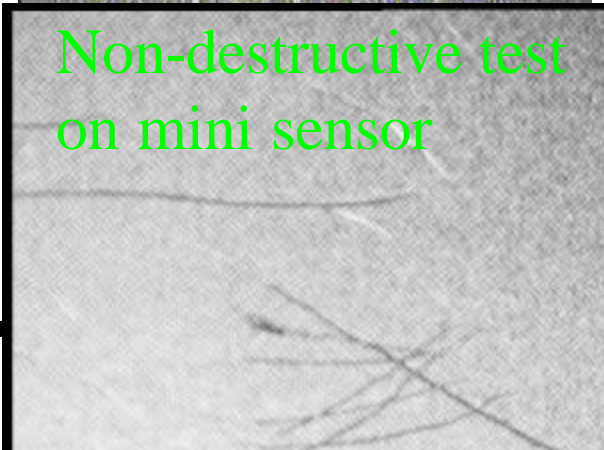
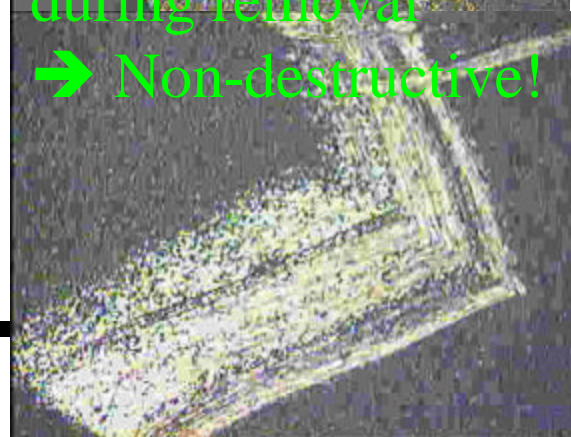
Backside – not critical

Non critical scratches on the backside compare with scratch tests on the backside and scalpel scratches (during removal), which **did not** increase the current.

Scratches on the back are probably not critical.

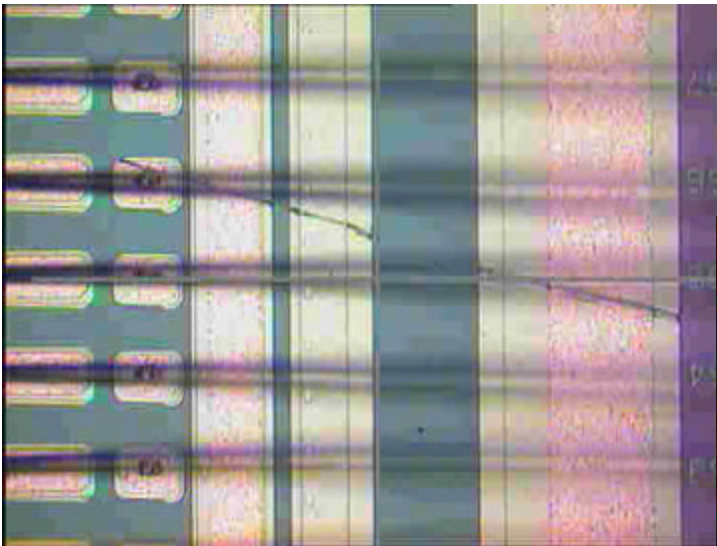
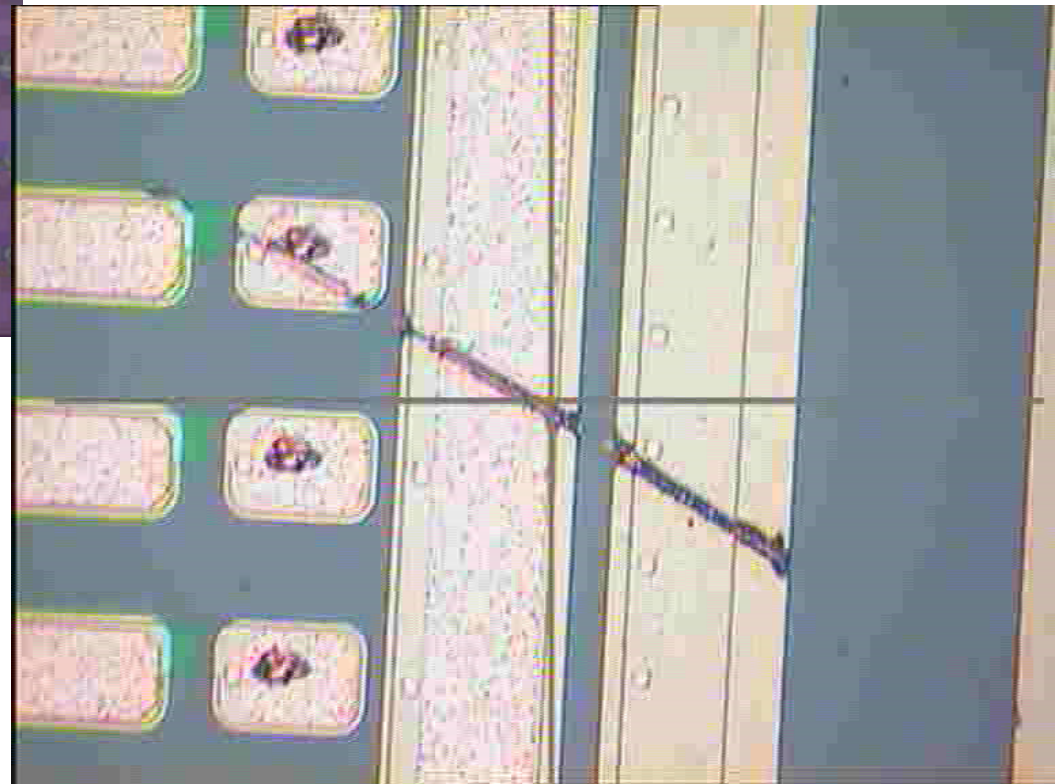
Scratch on n++, guard and bias

Scratch exists before end of bonding!

Possible defect candidate:
Metal overhang defect!

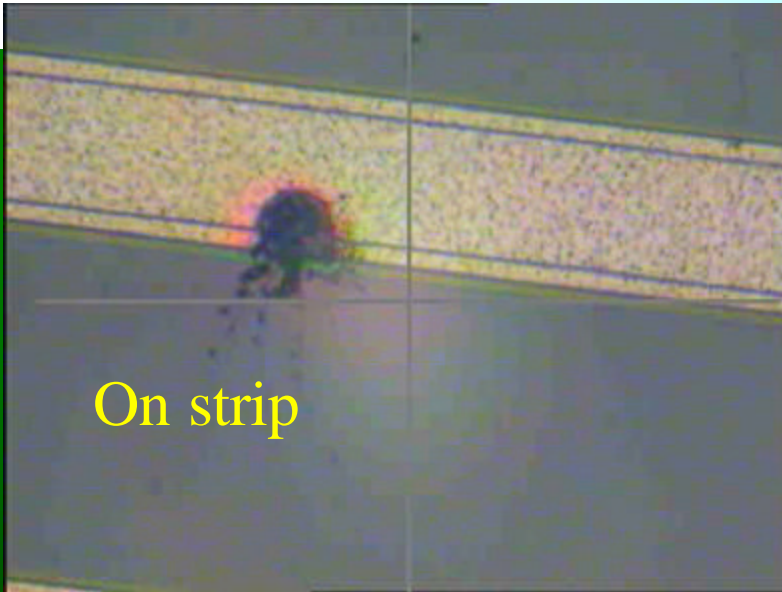
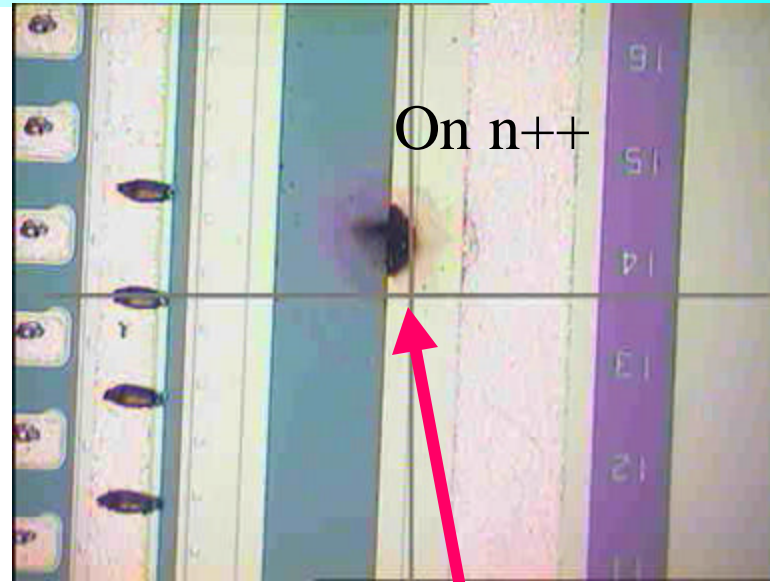
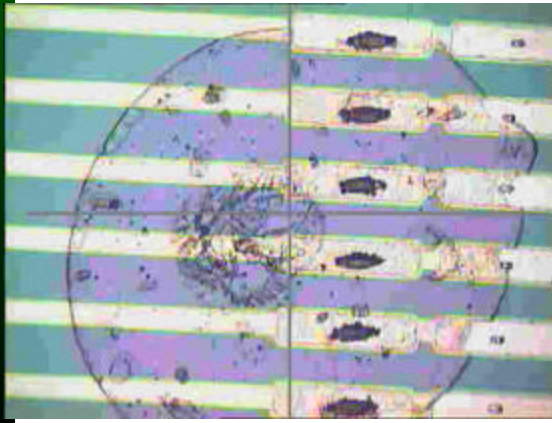
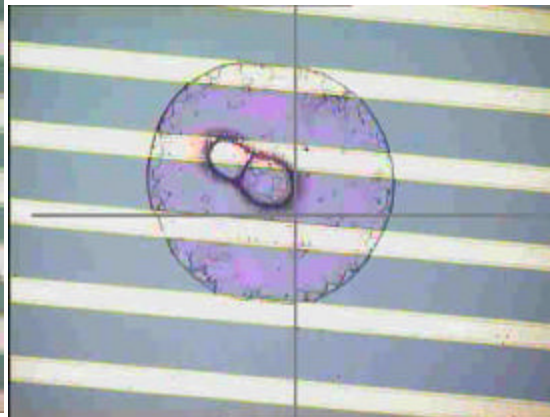
Module 643 (strange)

Possible defect candidate:
Short: n++ and guard

Most probable candidate!

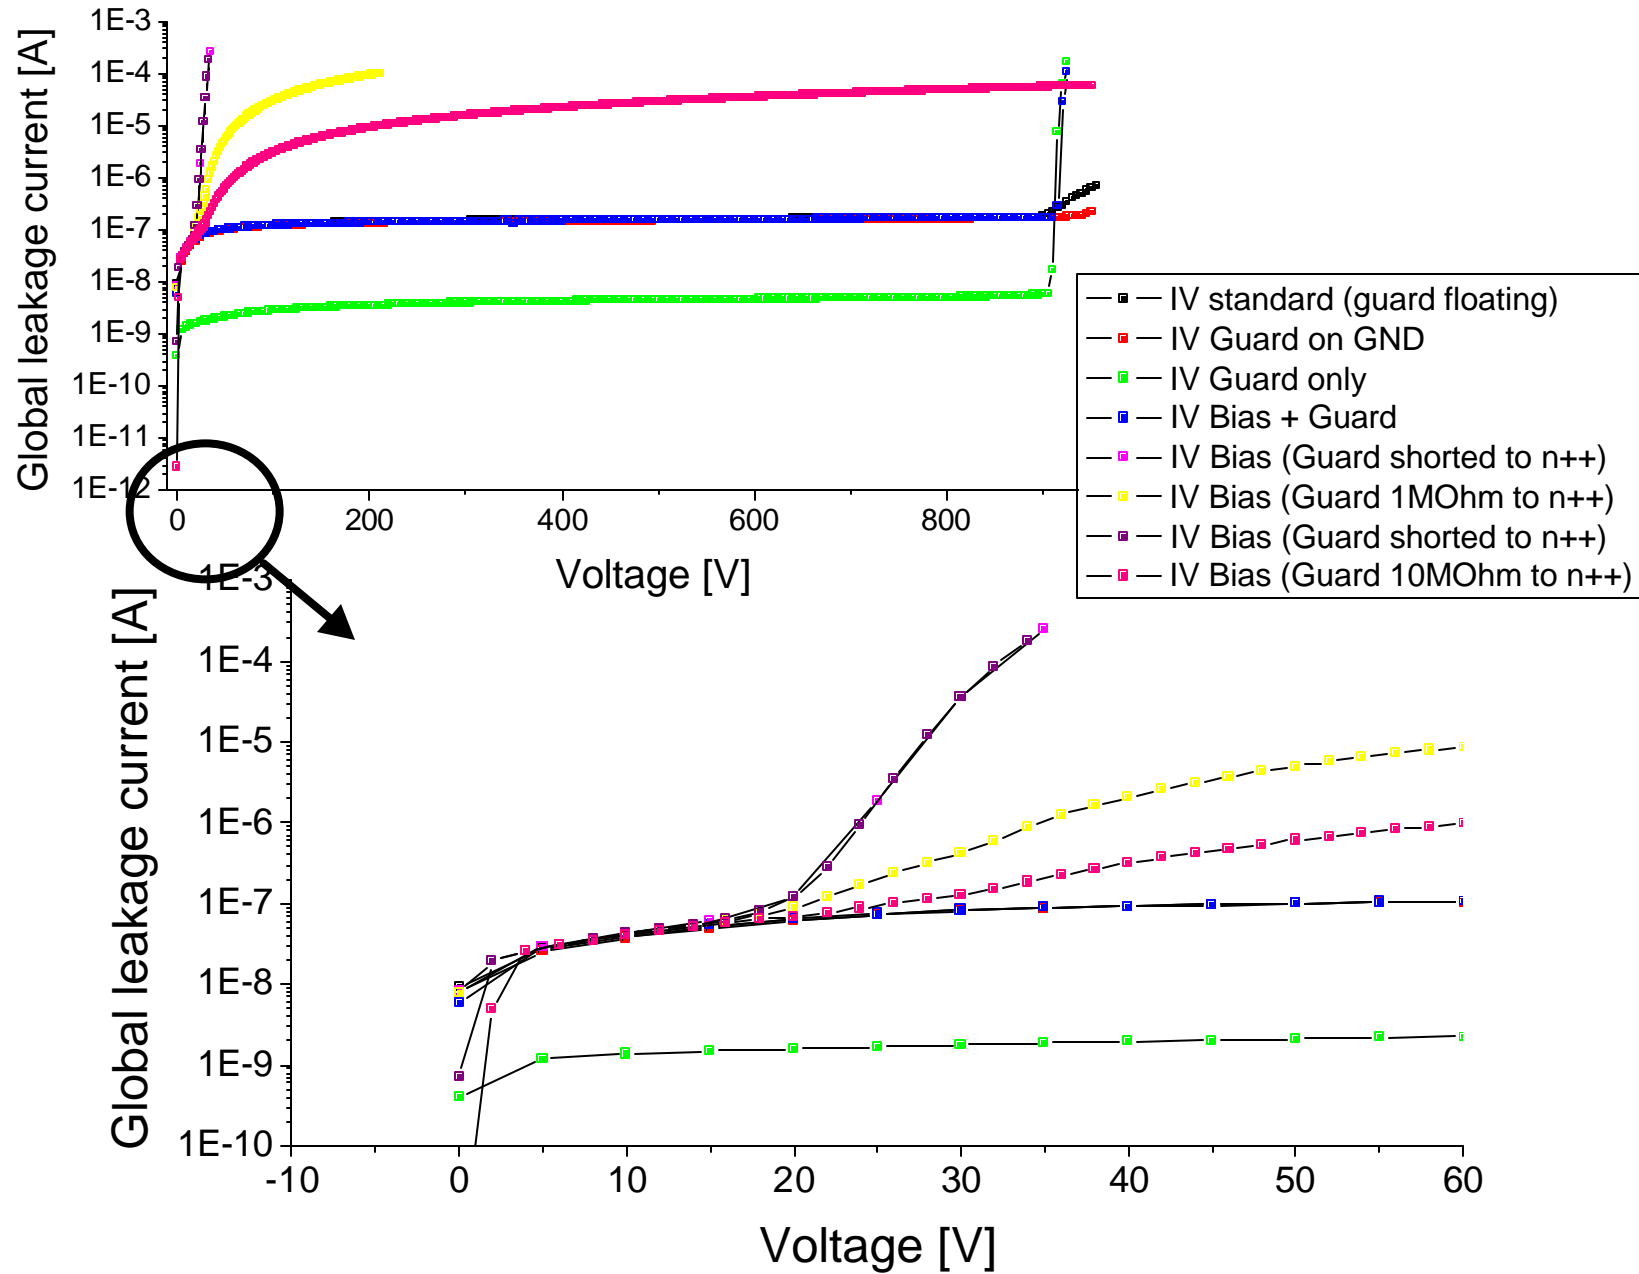
IV with “shorts” in the outer sensor areas
