TOB Modules with ST Silicon: Experience and Results from Recent Studies

Joe Incandela

For the US CMS Tracker Group

ST Workshop, CERN, Dec. 1, 2003

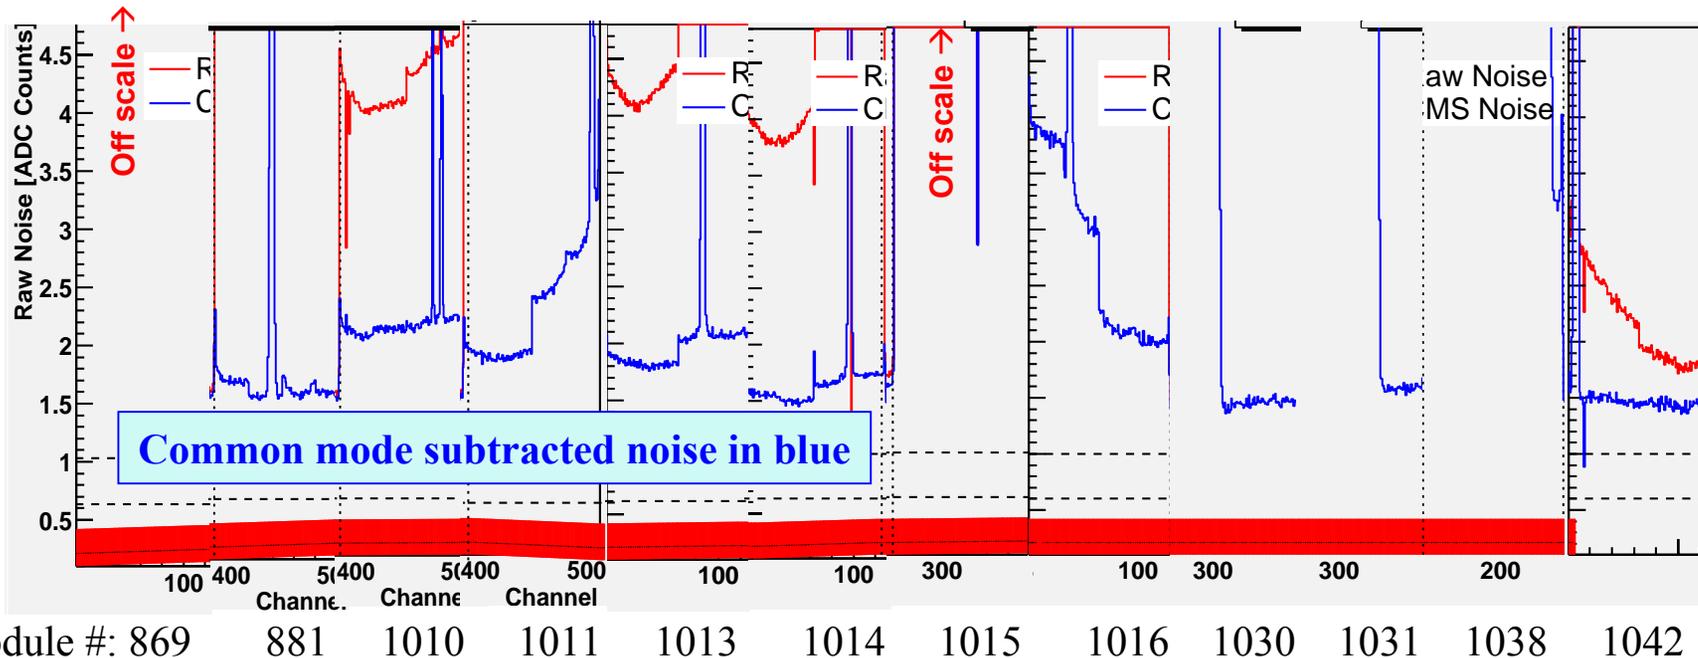
Montage of chips with CMN on 12 separate modules

For majority of modules with problems, the CM subtraction is imperfect. After common mode subtraction, many still have significantly elevated noise.

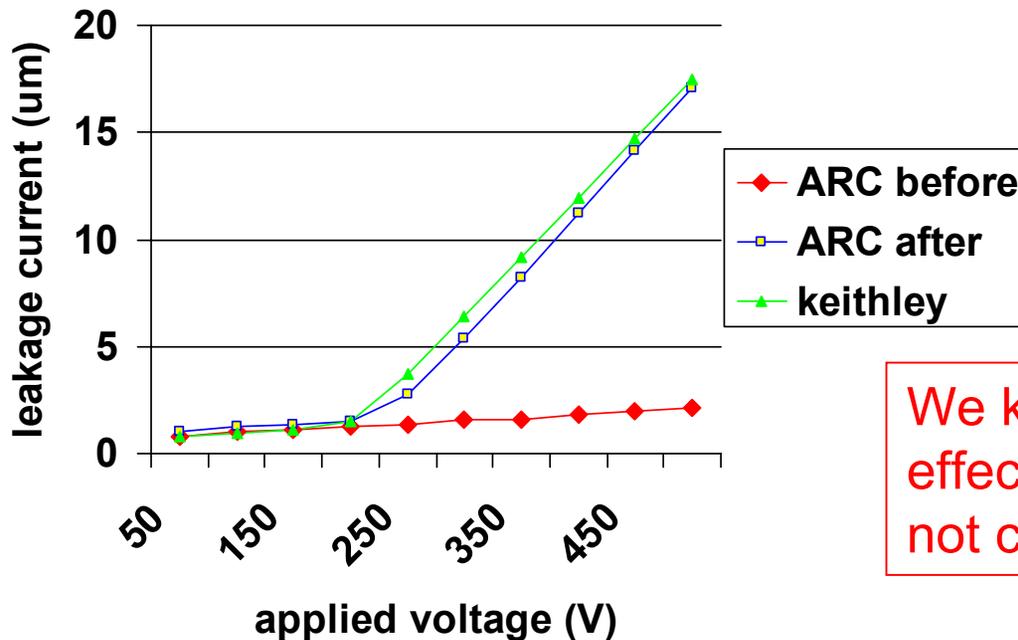
FNAL Module Spontaneously Develops CMN

- "before" measurement is taken on 09/08 on ARCS before LT
- "after" measurement is taken on 09/23 on ARCS after LT
- green curve is a measurement done using Keithley on 09/24 with 1 minute interval between steps

No visual defects are observed on the sensors around noisy channel #219

We know it is not a humidity effect: 3 weeks in dry air did not cure it

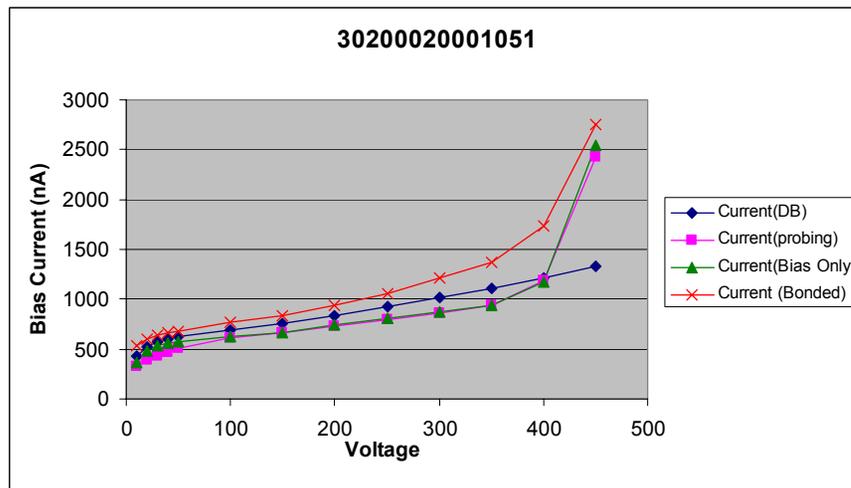
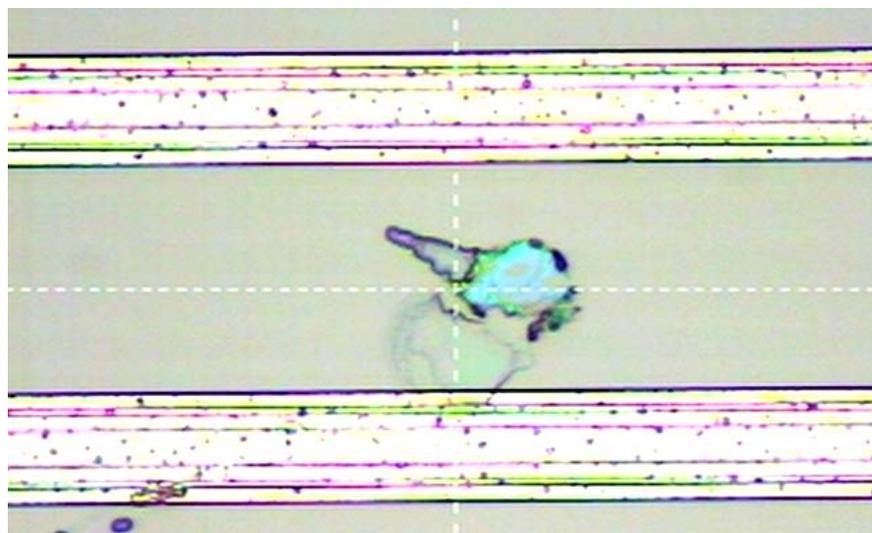
New CMN Problem Module (1051)

- Last SS6 module built using one sensor with 1.2 μA extra current (1700 nA vs 50 nA) in UCSB re-probing at 450 V.
 - Well within old selection criteria
 - No significant increase of current during module assembly
 - Uses somewhat older sensors
 - 30210320274206
 - 30210320274214
- CMN seen in chip 46 with extremely high noise in channels 423-424
 - Sensor flaw seen between two channels – not known if relevant.
 - Begins at 400 V where measured current diverges from database
~0.5 μA difference

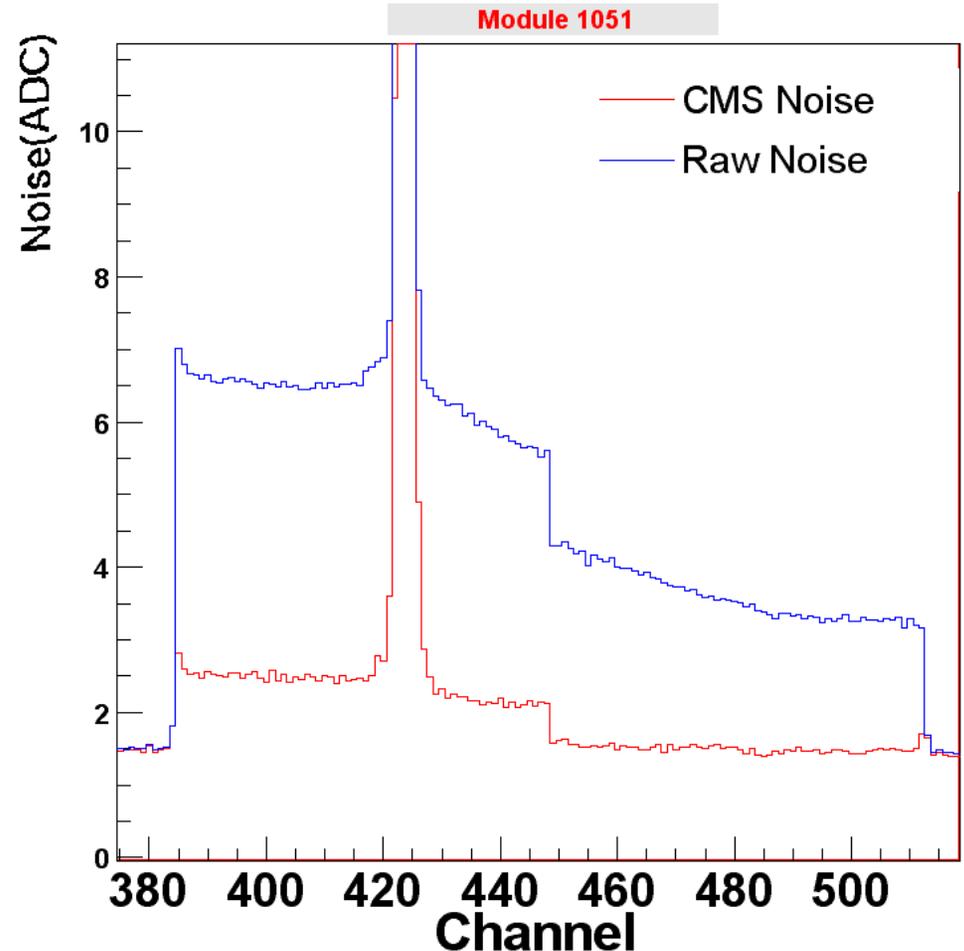
CM Noise on Module 1051

- Module tested at slightly elevated voltage
 - Bias current $3.7 \mu\text{A}$, $< 2 \mu\text{A}$ more than expected from database
- First half of chip has CM subtracted noise a factor of ~ 1.75 higher than typical.
 - A very little amount of micro-discharge can cause the CM subtraction algorithm not to work properly
 - CM subtraction algorithm used is same as LT, and test beam software

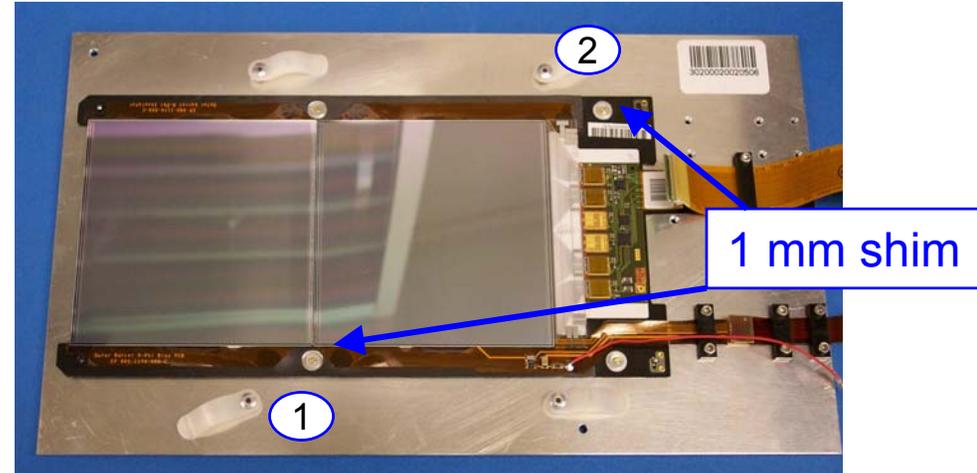
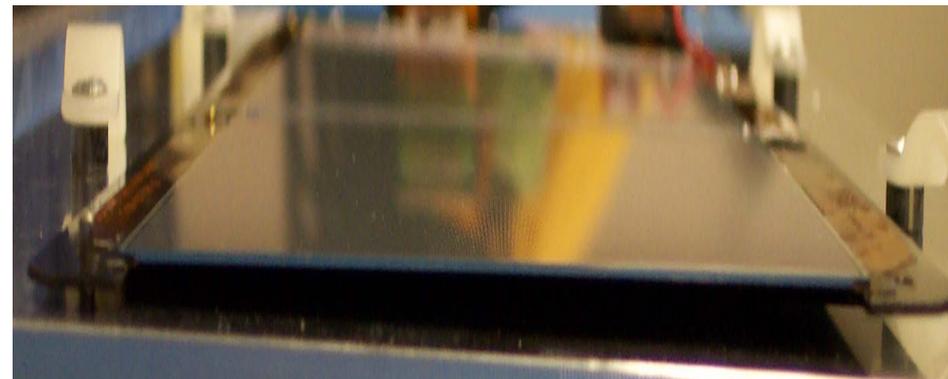
Mounting on cold plate

- Modules attached to cold plate with 4 screws through thermal contacts
- To test the effects of twisting modules, 1 mm shims added under thermal contacts
 - Bias current measured with 1 or 2 shims for all 10 modules
 - No observed change in current

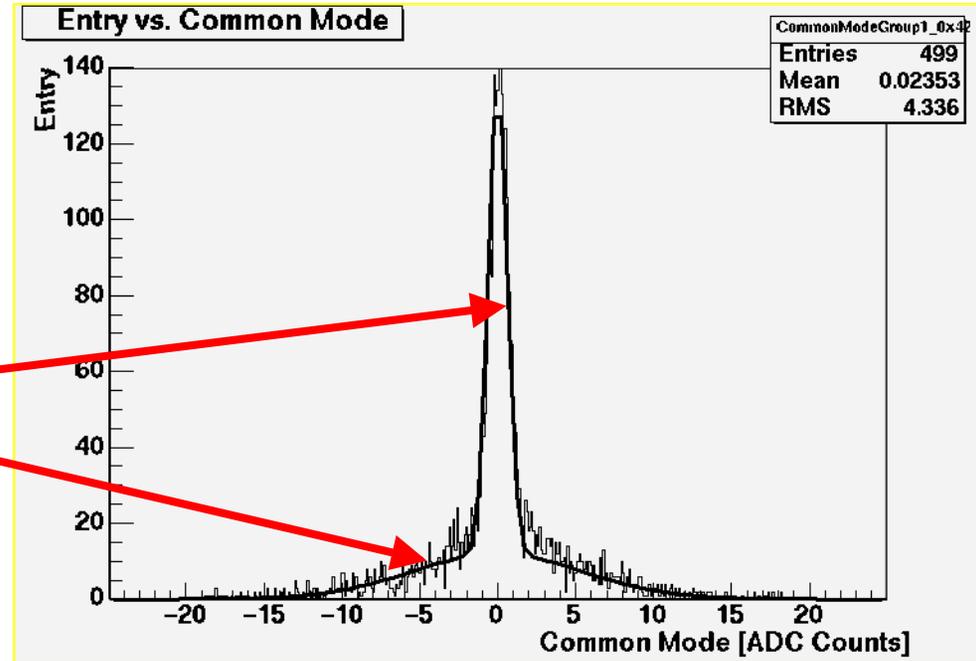
Study of CMN Spectra

- The common mode point is calculated event-by-event for groupings of 32 channels
 - The spectra of the common mode is fit for the groupings within a chip with CMN problems - excluding the grouping with the high noise channel
- Spectra is fit with two Gaussians
 - Central core \oplus tail
 - Fit parameters are:
 - Fraction of events in tail
 - Width of central core
 - Width of tail
- Study variation of parameters with bias current by increasing bias voltage in steps of 50 V

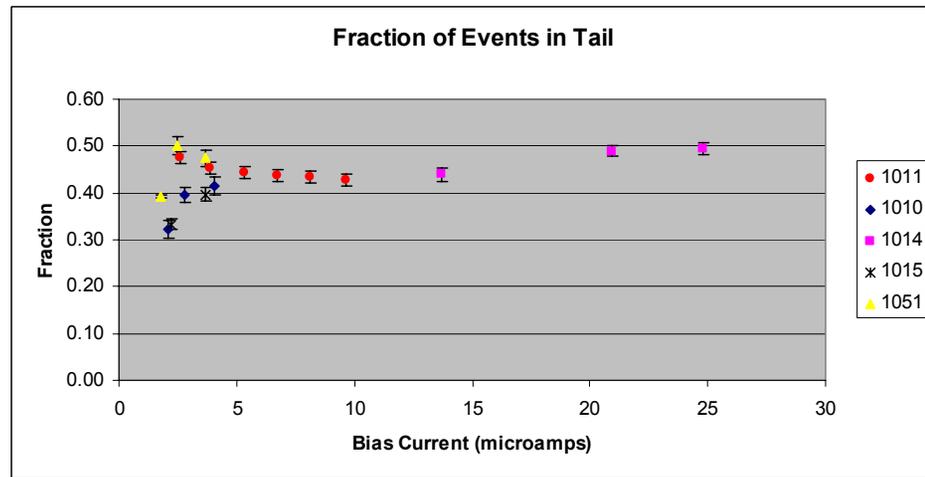
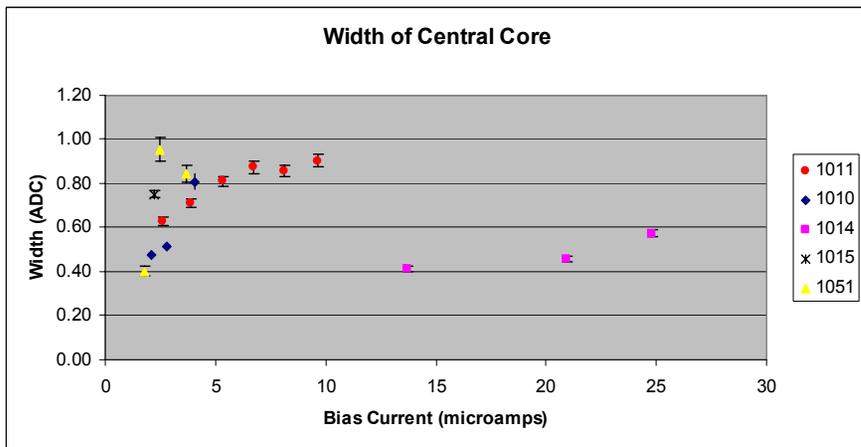
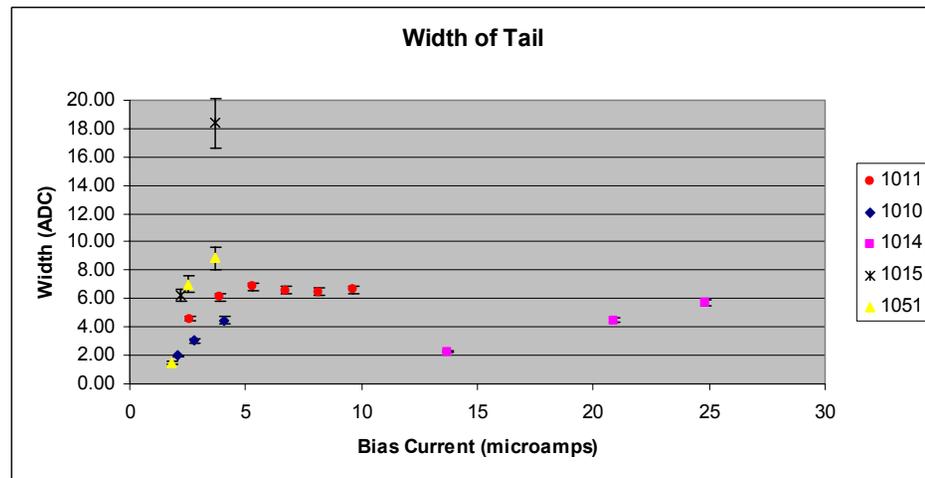
Fit Result of Common Mode Point

- Fraction of events in tail is relatively flat with bias current (~strip current)
- Width of central core increases with bias current (~strip current)
- Width of tail also increases with bias current (~strip current) and may flatten out at some current
