HORT20019 URBAN TREE MANAGMENT
TREE REPORT
PATRICK HONAN 688401

Report on *Eucalyptus cladocalyx* , located at reserve on 570-572 Swan St
Burnley VIC 3121, -37.826825, 145.016634.
Assessments carried out August through September 2015 by Patrick Honan.

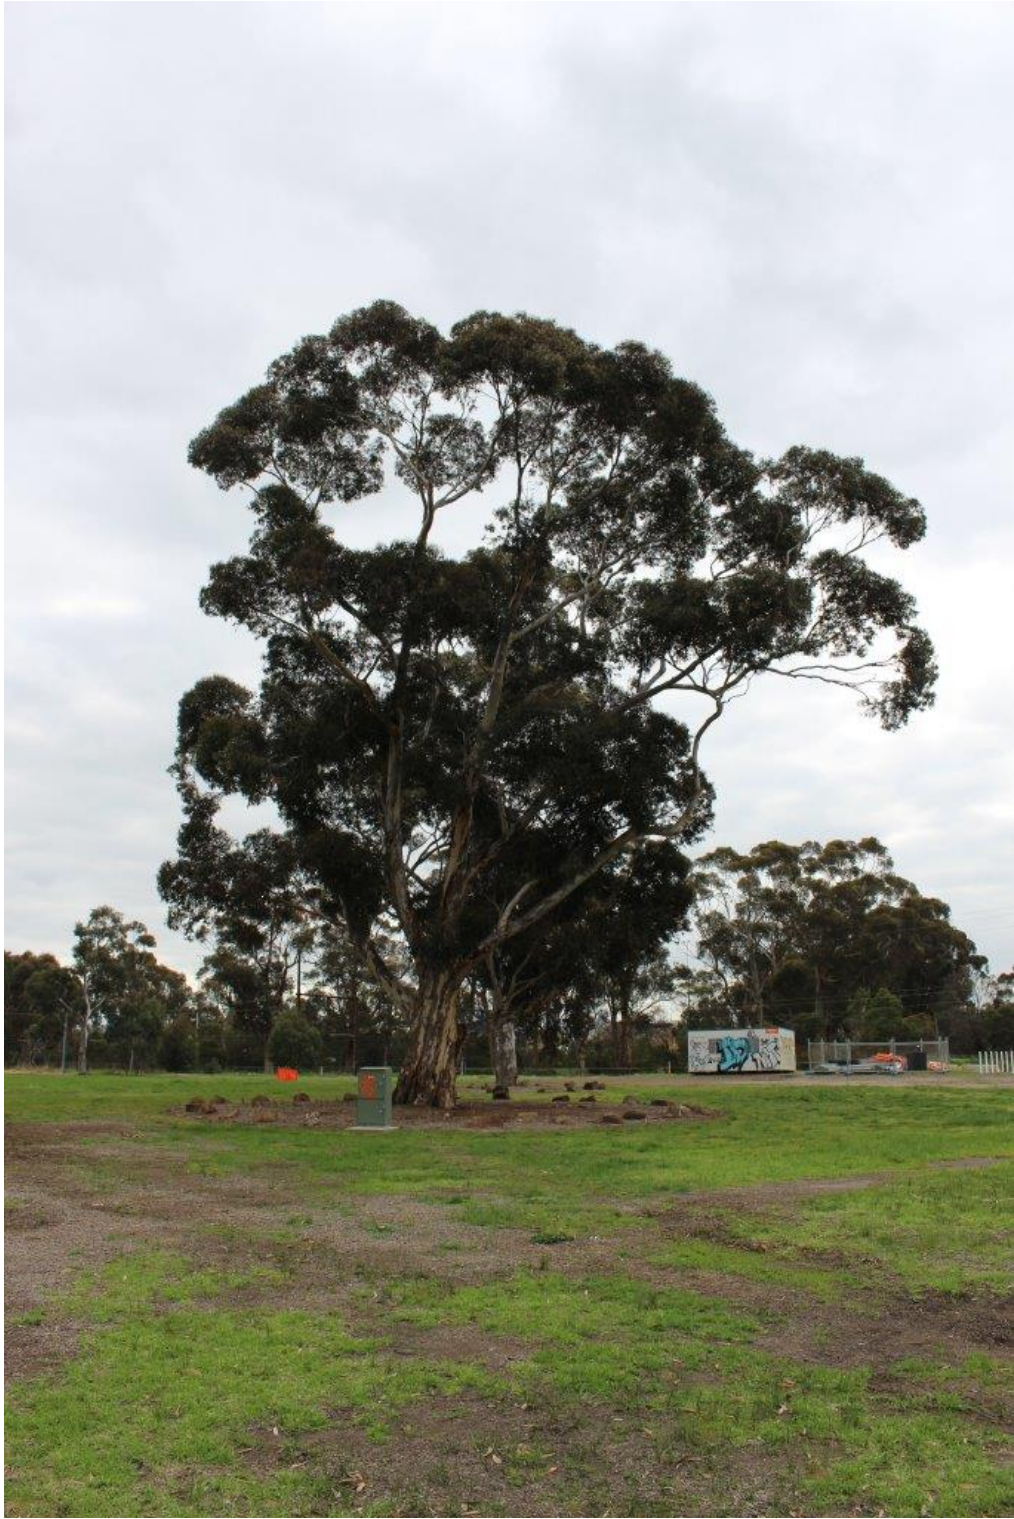
The specimen is an open-grown park planting set into turf and mulched to the canopy line (FIGURE 2). At the edge of canopy there is a power box (approximately 1 metre high, see FIGURE 2), used when events are held in the space. The council has installed a ring of small boulders at the canopy line where the mulch begins, in an effort to deter foot & vehicle traffic (FIGURE 8). The tree is fully exposed to prevailing westerly winds and other environmental & weather conditions.

The tree exhibits a notable lean of approximately 10 degrees (FIGURE 2). There is no mounding of soil visible. Tree lean is a common defect leading to failure that can be symptomatic or aggravated by root damage or restriction (Harris, Clark & Matheny 2004). This is particularly relevant given the decay observed at the root collar, which as discussed may extend below soil level. If these are related symptoms, then it may suggest an issue with whole tree stability. Thorough observation of the soil for cracking (the first sign of tree wind throw) (Mattheck & Breloer 1994, Matheny & Clark 1994) was not possible due to mulch layer on site. The exposed nature of the site compounds the potential for failure and wind throw.

Figure 2-Subject tree and surrounding environment

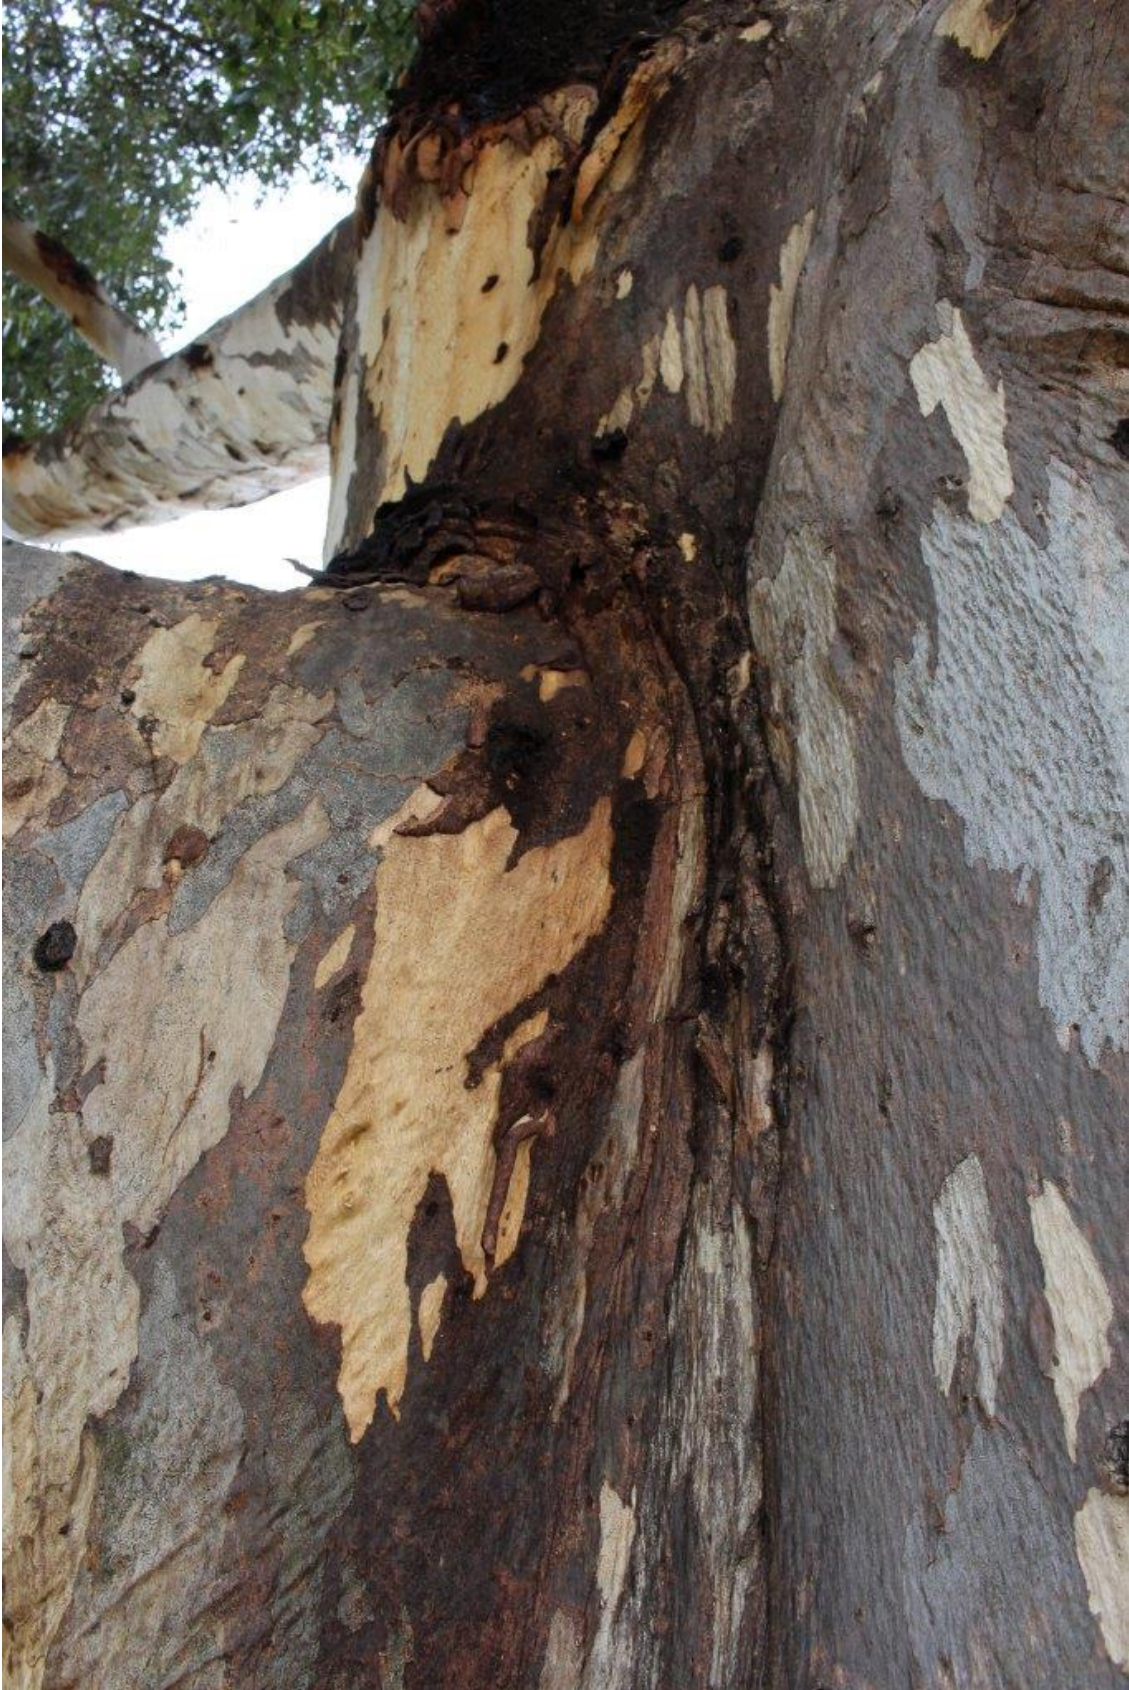
Refer to FIGURE 3 for photo, depicting included bark at branch union. Such are inherently weak, as connective tissues are unable to properly form at the join (Matheny & Clark 1994). As decay increases at the site of inclusion, so does the potential for failure (Matheny & Clark 1994). This defect is rated at “low”, see APPENDIX; the target zone for this defect is rarely to occasionally occupied, the tree is exposed to windy conditions & the genus has a habit of limb shedding (University of Melbourne 2015). Though the defect is likely to fail at some point, there is no indication that this failure is imminent, with no additional swelling at the branch point. As the branch is of a significant size, failure and shear will expose a large portion of the cambium to decay.

The defect will require future monitoring. As the tree grows, the accumulation of included bark will increase stress on the union with time. The risk represented by this defect will increase as the tree ages (Matheny & Clark 1994).

Figure 3- *Included bark at branch union*

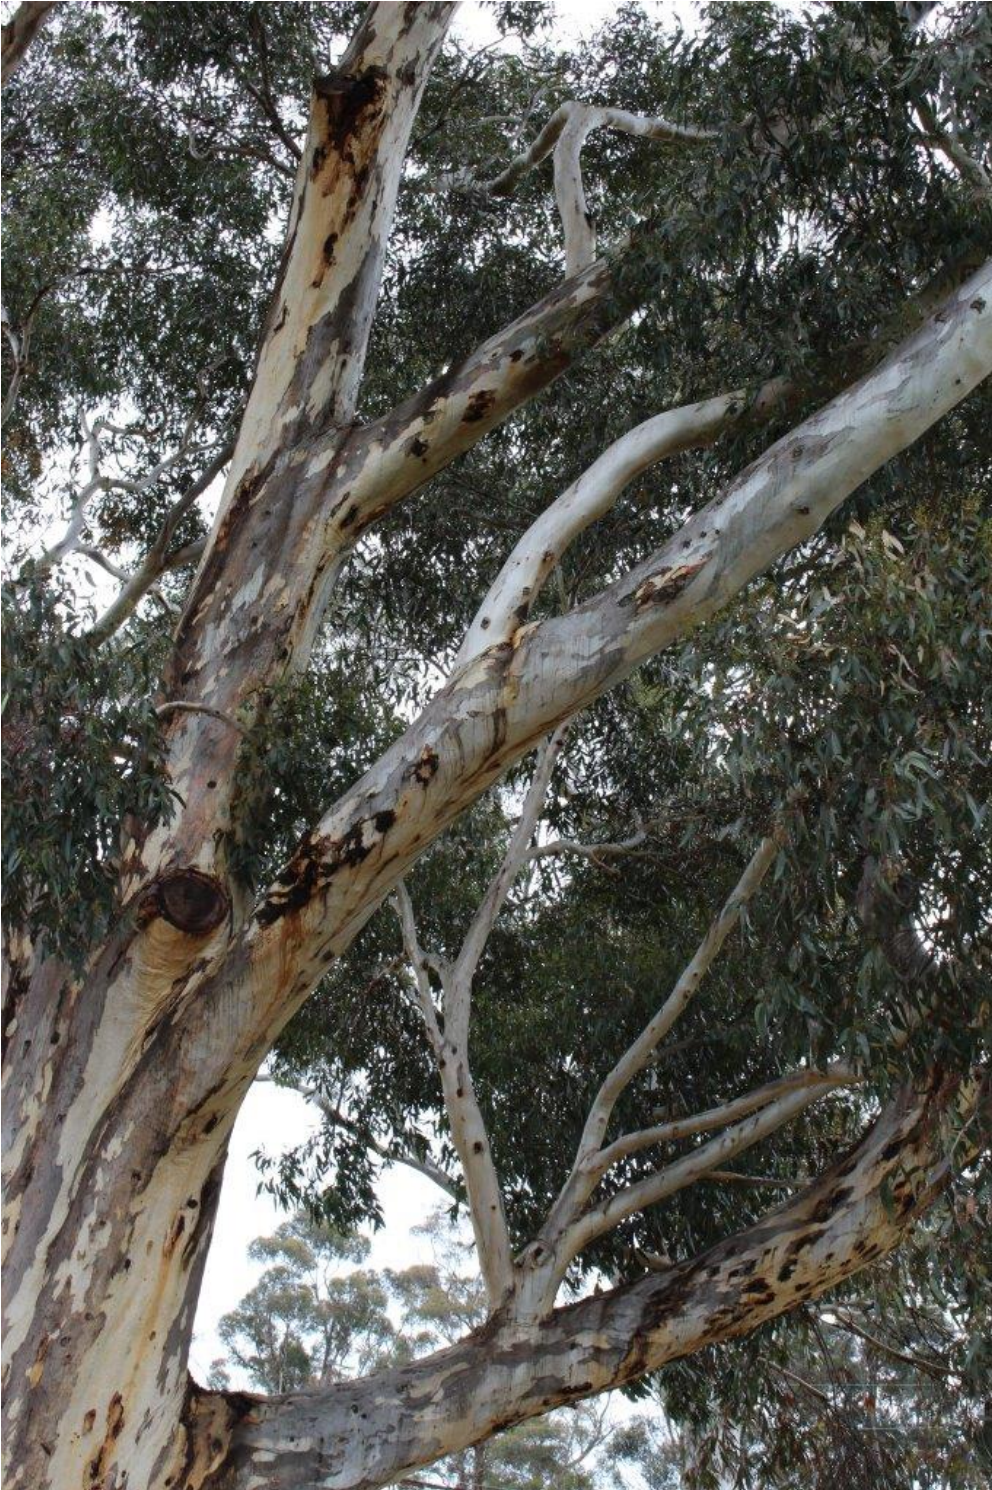
Refer to FIGURE 4 for photo, depicting a variety of epicormic branches shooting vertically from midpoints in horizontal branches. Such growth is an indicator for environmental stress. These shoots arise from latent buds or meristematic points along the lower trunk, large branches, and pruning wounds (Konijnendijk 2005). In this case we can suggest such growth is a response either to evidenced improper pruning technique, or previously detailed environmental conditions. Harris, Clark and Matheny (2004) note epicormic shoots as a symptom of tree decline.

Epicormic growth form poor tree architecture and have weak branch union, as they are not joined all the way to the centre of the stem (Albers, Pokorny & Johnson 2003). These unions have no observable indicators that suggest failure is imminent. As it is a structural fault it will require future, ongoing monitoring. However it is not significant with respect to tree hazard potential at this immediate time.

Figure 4- *Multiple epicormic branches throughout the tree*

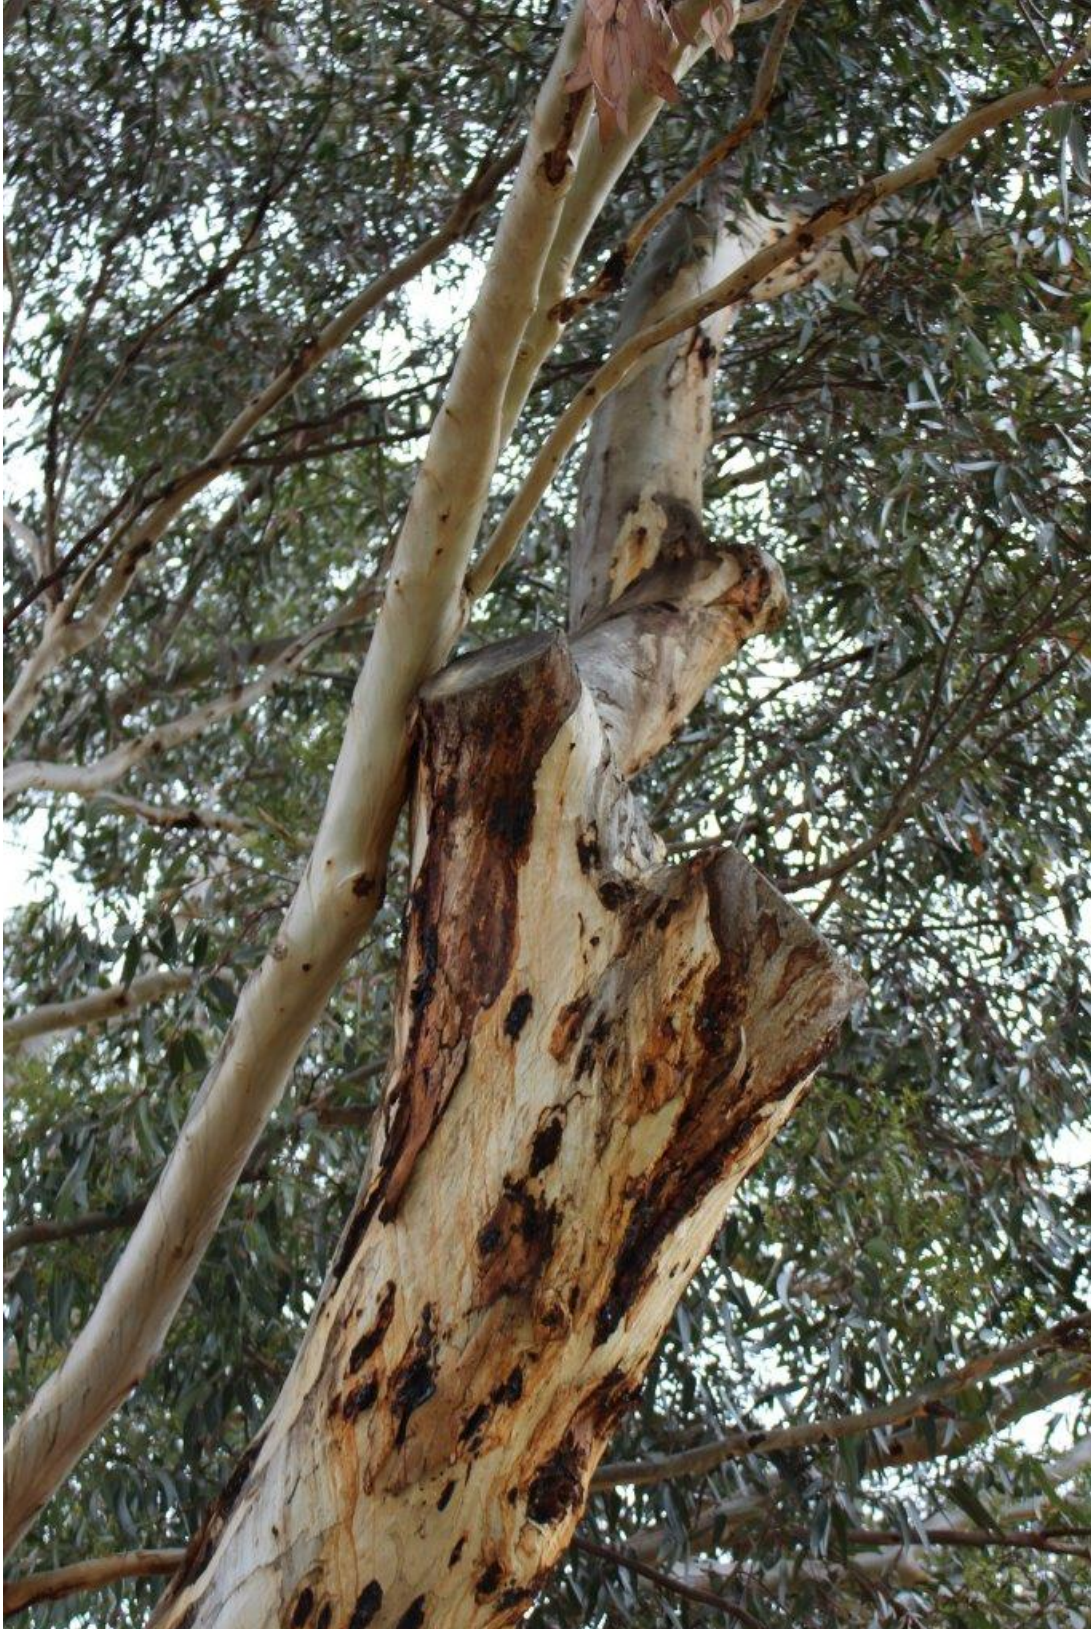
FIGURE 5 shows how inappropriate pruning technique or storm damage has led to stripped bark and partial limb loss. Such wounds usually damage important conducting tissues for the tree (Shigo 1985). These wounds also act as a vector to expose the inside of the tree to pathogenic organisms, primarily bacteria and fungi (Raven, Evert & Eichhorn 2005). These infections lead to decay, and shorten the life and structural integrity of the tree (Shigo 1985).

Figure 5- *Torn bark, cracks and decay from limb shear or improper pruning technique*

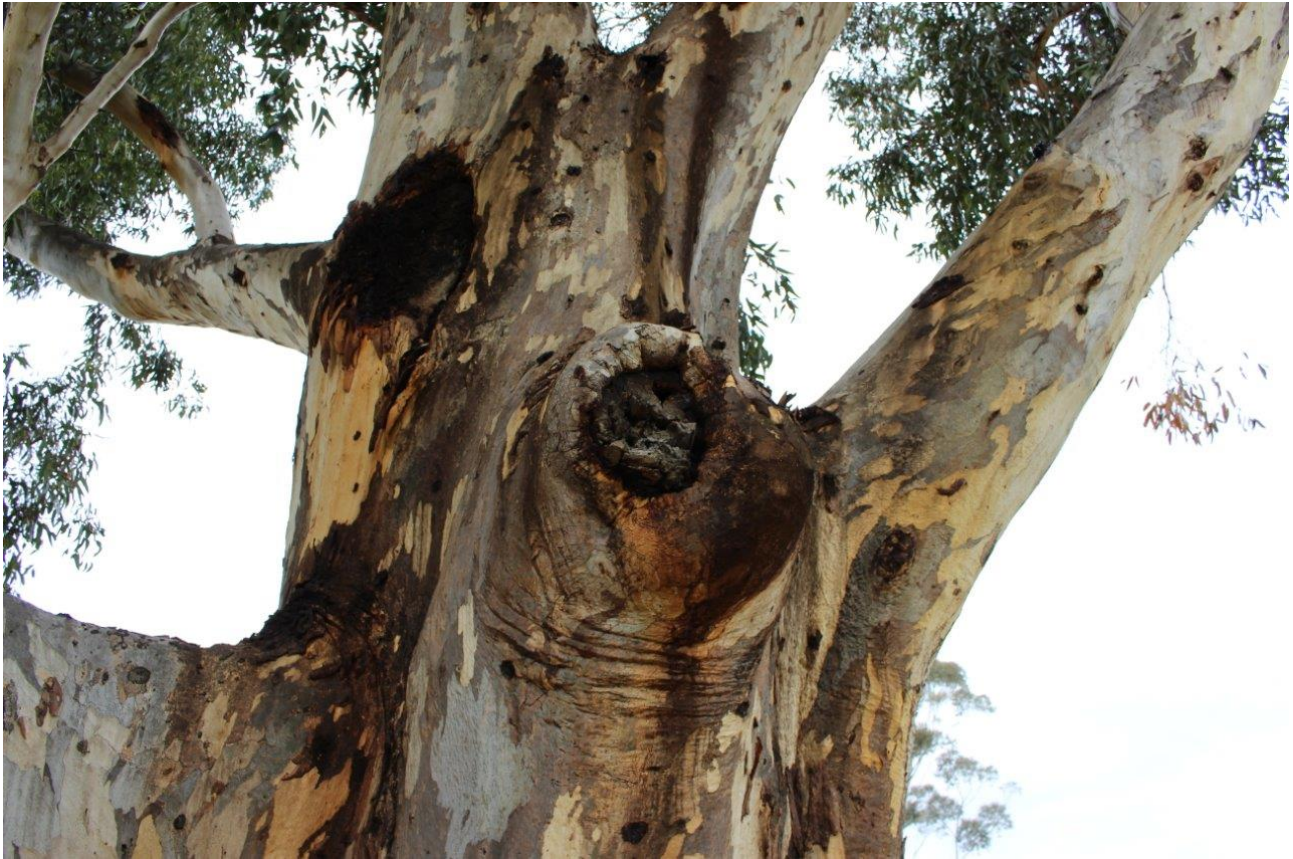
FIGURE 6 shows in one location how either inappropriate pruning or complete limb shear has led to a failure of a healing and covering response from the tree. The result is the exposed wood has begun to decay, compromising the integrity of the trunk and acting as a vector for pathogen attack. The presence of borer holes is noted, suggesting insect damage which is discussed later.

Figure 6- *Decay setting into trunk from tree being unable to properly cover wound following limb shear or improper pruning*

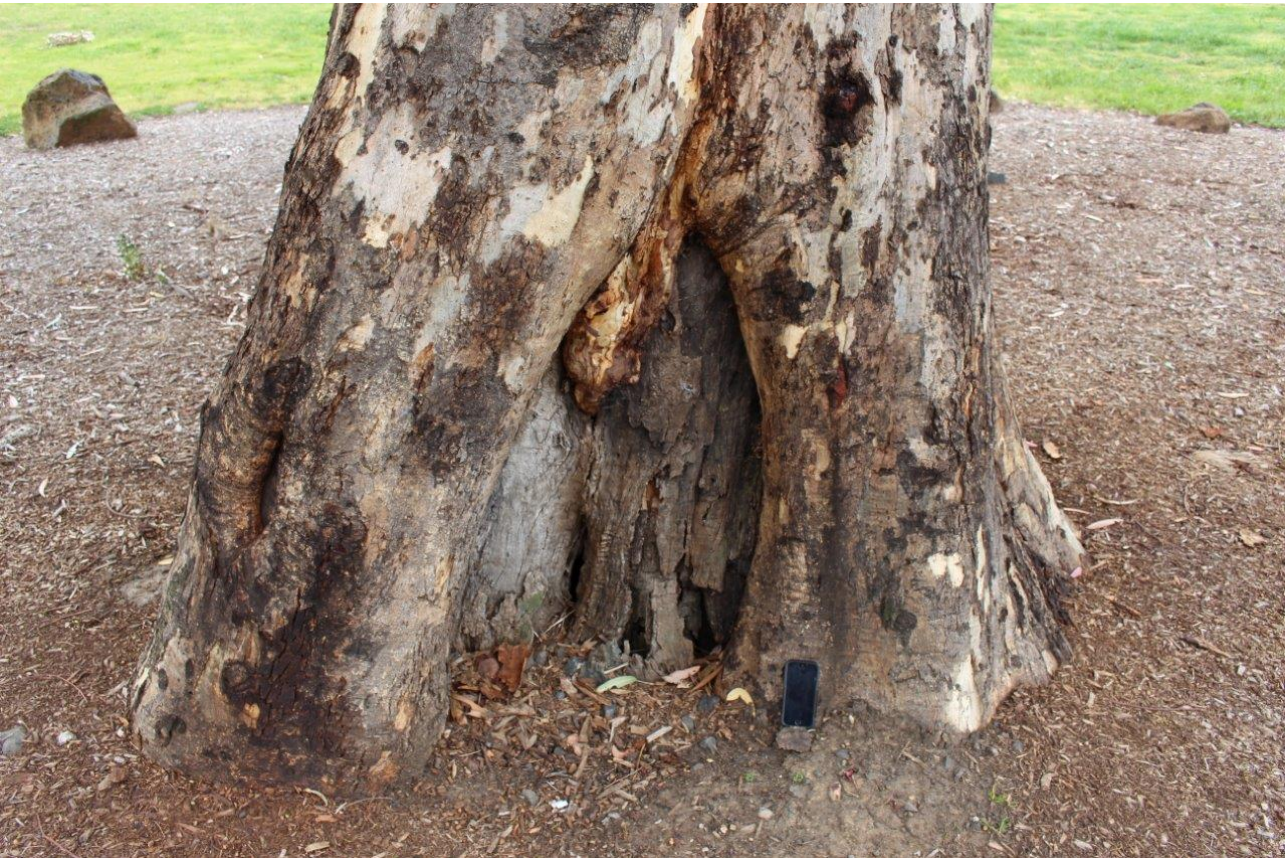
FIGURE 7 depicts significant scar and rot of heartwood at base of tree, extending down to the root collar. This decay may extend into the root system. Tankersley (2015) notes that such decay is a major cause of tree failure due to the inflexibility of dead tissues. This is a significant problem when present in the trunk, as healthy trees are required to bend and sway (Tankersley 2015), and is particularly relevant given the exposed site for this tree. It should be noted that Tankersley (2015) states that vigorous trees have been observed to grow more sound wood around the hollow, compensating for that lost to decay. Compartmentalisation of the decay also prevents spread and size of the damage from spreading (Shigo 1985).

The placement of this scar needs to be considered, and its proximity to the root system. Raven, Evert & Eichhorn (2005) note that such wounds act for a vector for infection and decay. Tankersley (2015) notes the importance of roots in anchoring the tree, and states that any damage to the roots will come with a corresponding probability of tree failure, and that damage by decay may cause the tree to be more susceptible to wind throw. This is particularly relevant given the trees exposed position and angle of lean.

Figure 7-Scar and decay on base of trunk at root collar, possibly extending below soil level. Iphone pictured for scale

Use of ground penetrating radar is a well documented solution (Stokes et al. 2002) that is appropriate in this context to establish the extent the decay has spread into the root system.

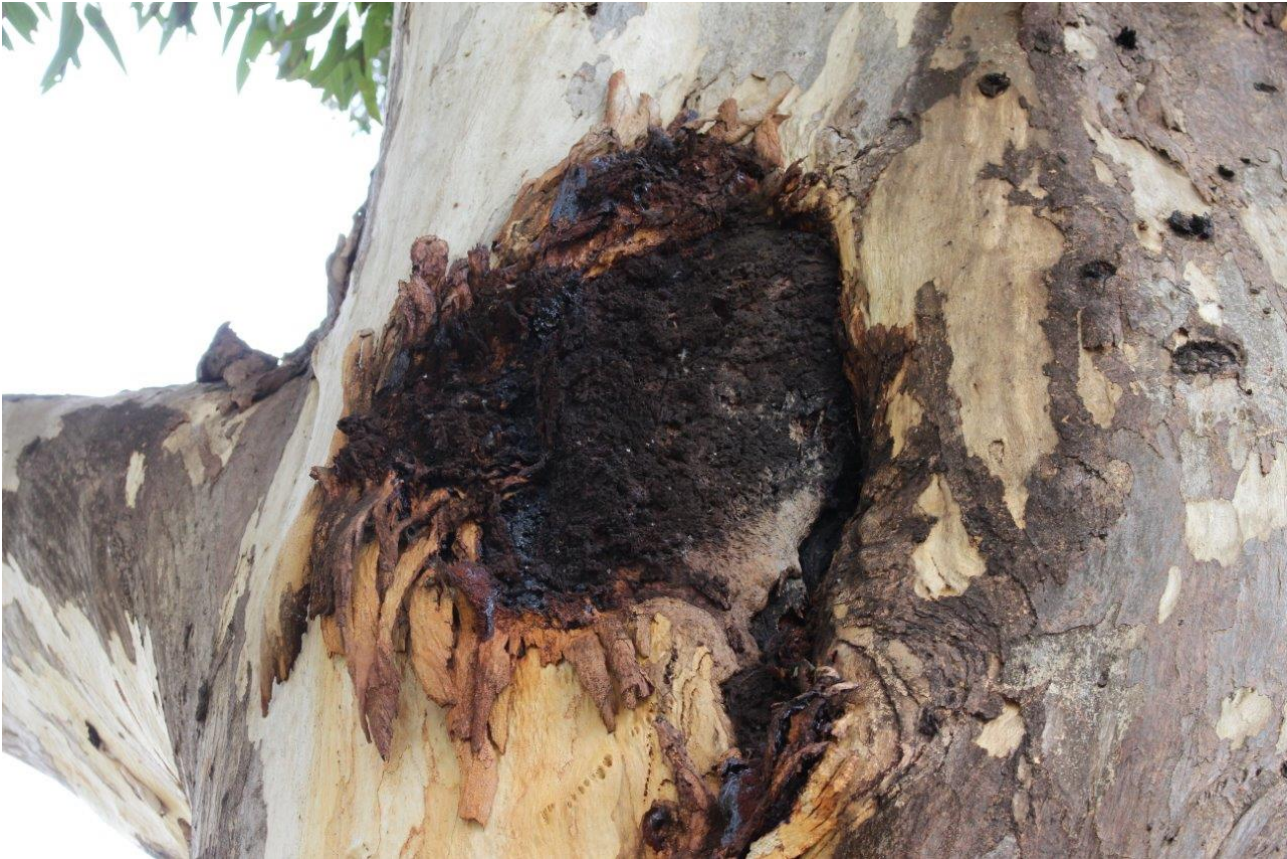
Unhealed wounds from limb removal on trunk show evidence of decay and frass, suggesting potential borer damage (FIGURE 8).

The holes are also observed intermittently on the trunk, and are suggestive of *Phoracantha semipunctata* (Gerozisis & Hadlington 2004). The presence of this insect is likely secondary to an overall decline in health in the tree, as it usually effects dead or dying trees (Museum Victoria Biodiversity Snapshots 2014). The damage carries into the sapwood of the affected tree, which could act as a vector for other pests, disease and decay. Already the presence of decayed tissue is observed at the surface. It is not possible to determine if this has been directly caused by the pest insect, or the limb shear previously discussed. In great numbers the pest can completely destroy phloem-cambium region on which it feeds (Gerozisis & Hadlington 2004), and so further surveying is required to establish extent of infestation

Figure 8-Evidence of frass in wound suggesting presence of borers

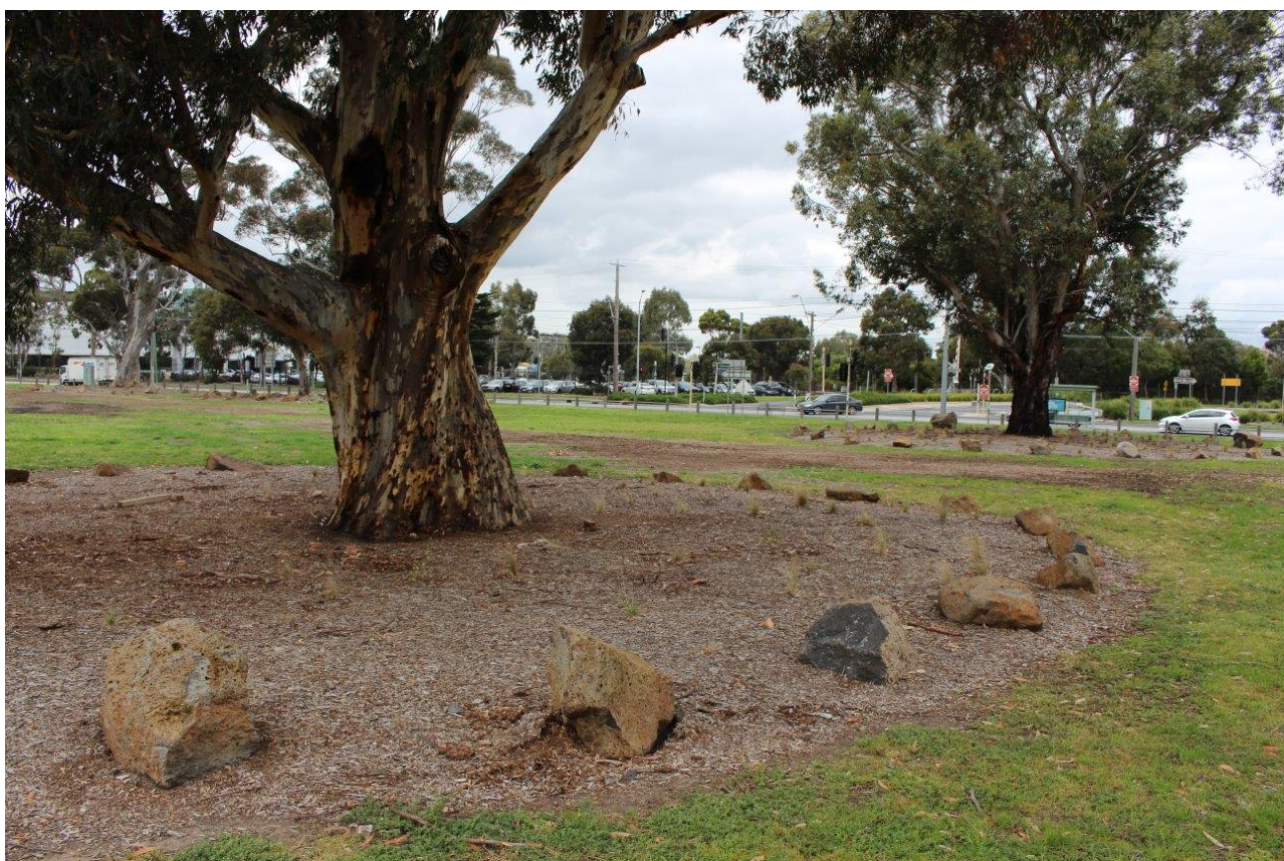
The impact of any of these failures is linked directly to occupancy rates. Although the reserve is open and publicly accessible, it should be noted that the council has taken steps to dissuade public use under the canopy. This is achieved through embedded rocks to prevent cars from accessing the area, and mulching around the canopy to discourage people travelling and stopping in the area. This is depicted in FIGURE 9. These steps work well to curb the potential failure and impact, as occupancy rates are discouraged and decreased. However, it should be noted the occasional tenancy of this land for events as leased by the council is a unquantified variable to occupation rates, and therefore risk and impact.

Figure 9-Risk mitigation (mulch and rocks) installed by council to deter both vehicle and foot traffic from canopy line of tree
