Vjg!Itgcv!K4E!O {uvgt{ Cev!4

Summary of Status

- The test systems in FNAL and S.Barbara have shown that (rarely) the I2C between CCUM and FEH and/or AOH can generate errors
- This was traced back to a timing problem occurring under certain conditions on the I2C bus
- The two signals on the bus (SCLK (i.e. clock) and SDA (i.e. data) are not properly propagated electrically along the TOB control chain: CCUM->ICC->Hybrid

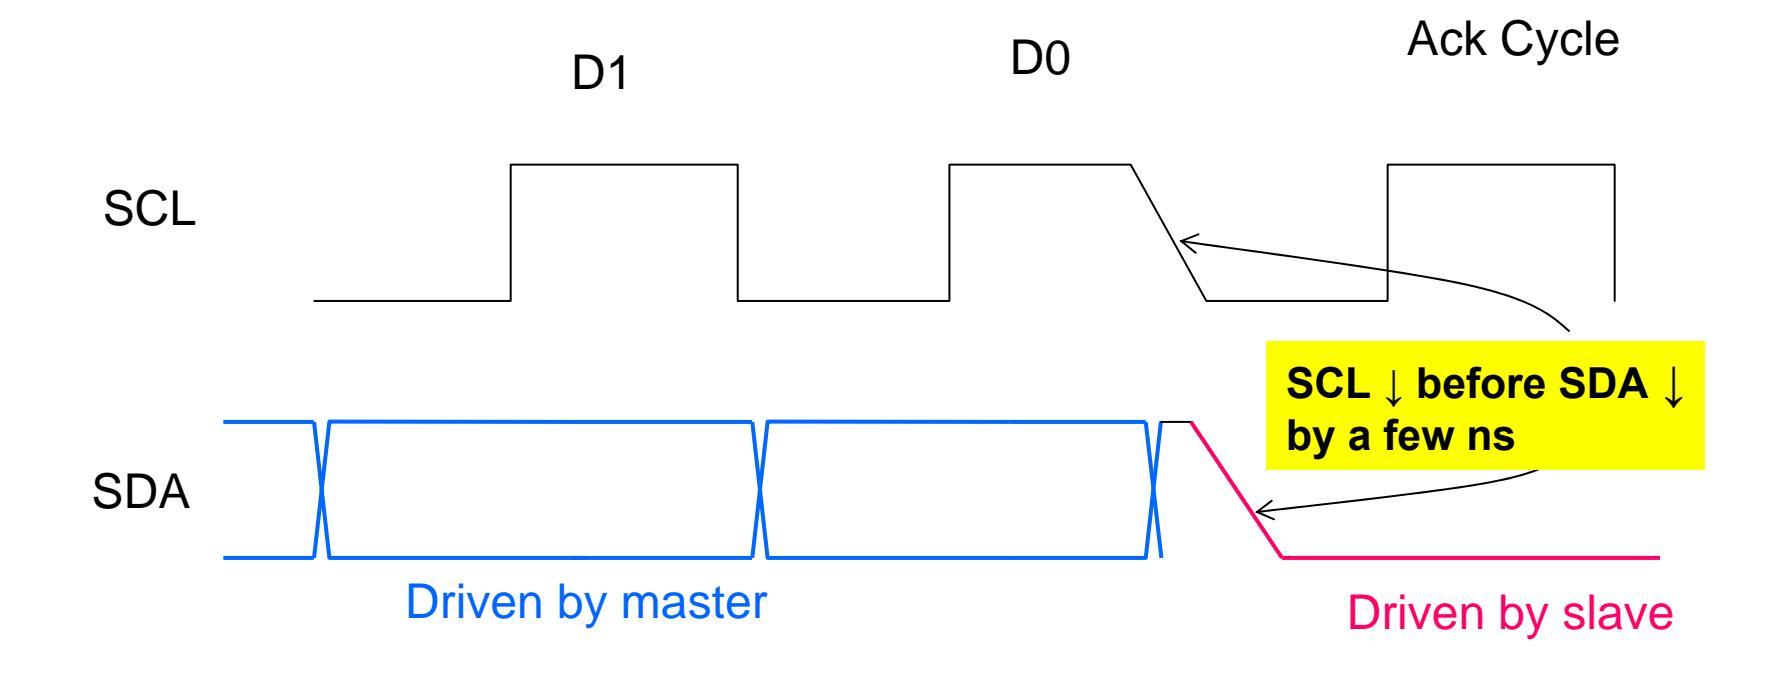
The actual waveforms

- Occasionally, when accessing sequentially components on the I2C bus (LLD, DCU etc.), the APVs are found not to respond correctly to I2C commands, actually they are stuck
 - This can data pattern dependent (as the last bit of the data sequence is the one most often misinterpreted)
- The lock-up can only be cleared by Resetting the APV

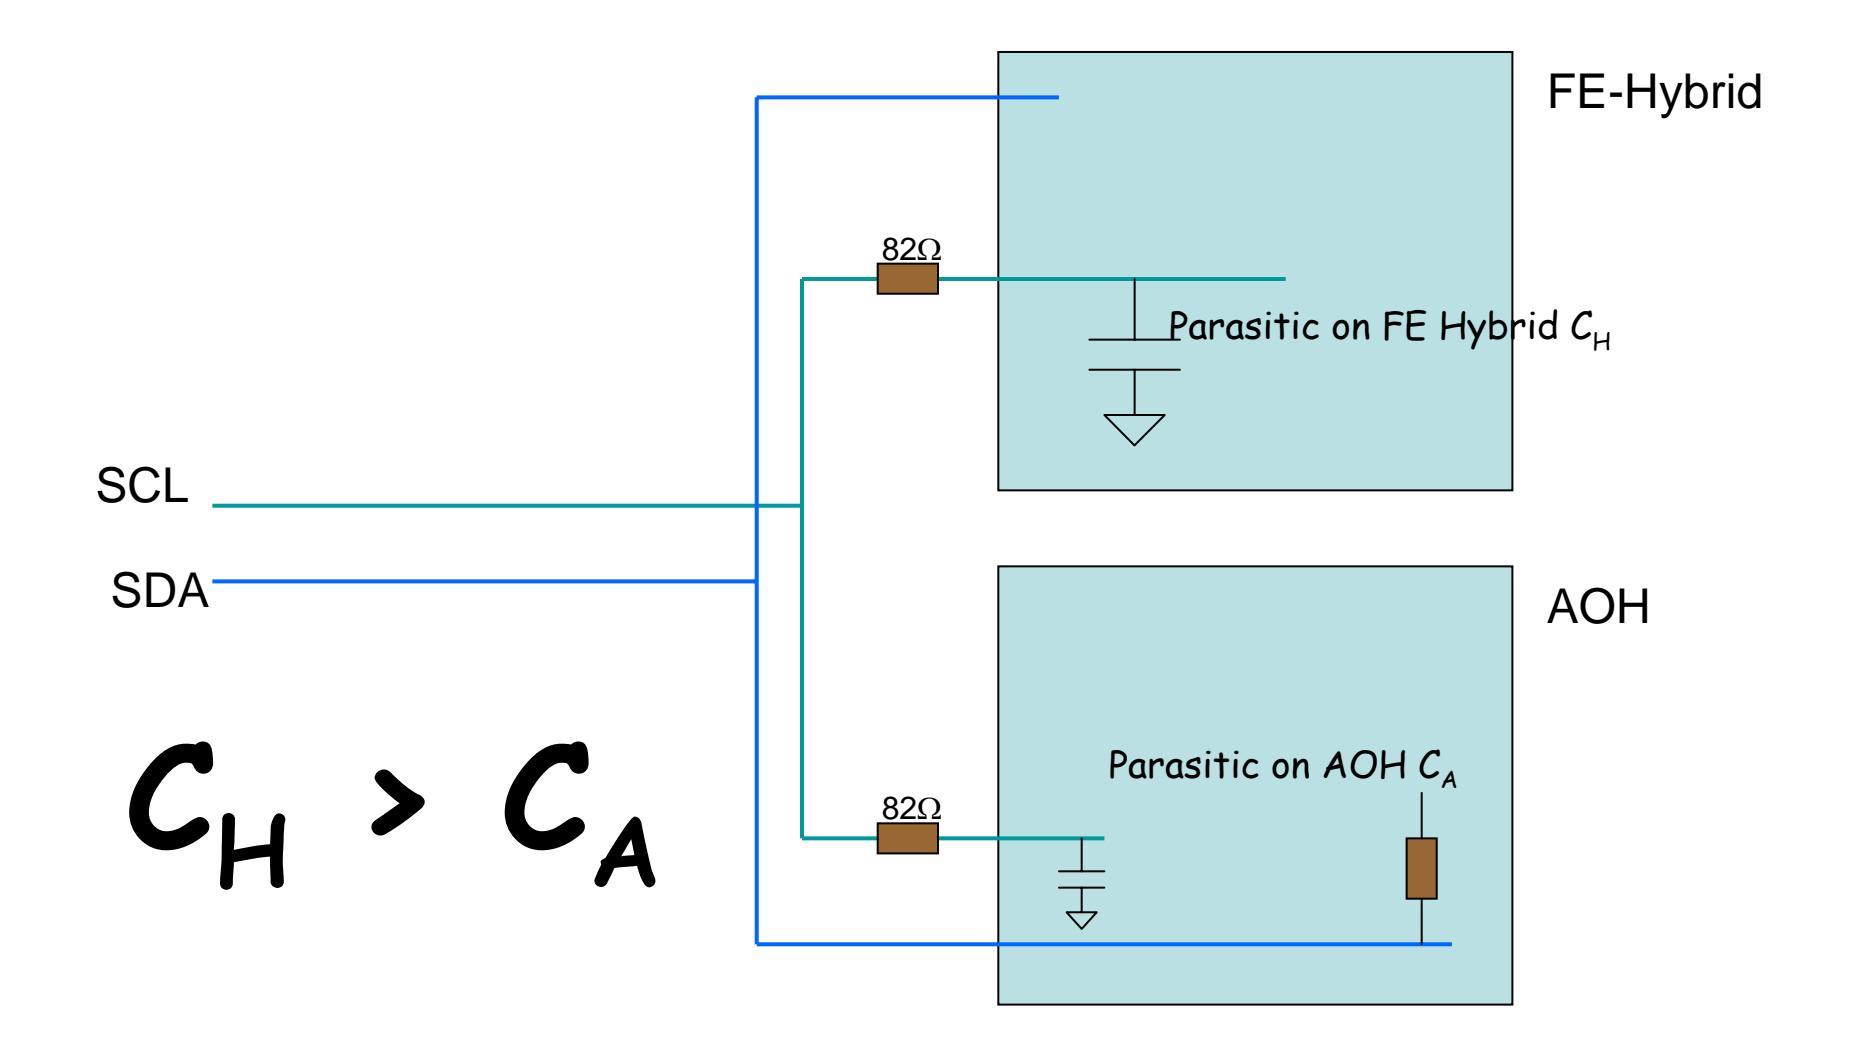
Present Electrical circuit

- Through a combination of:
 - Minor weaknesses in implementation of I2C protocol
 - Unfortunate choice of layout in interconnect card ("T" line layout instead of linear transmission line)
 - High capacitance of FE hybrid
 - Improper choice of inductive signal transmission in Kapton pig-tail on FE hybrid
- It results in:
 - Unsafe timing margin between SCL and SDA line as seen on FEH and/or AOH,
 - to make things worse this is (I2C) data dependent

- Remove all protection resistors as to avoid different RC constants on ROD traces and introduce strict powering sequences
- 2. Use Wacek's ~2 nF bypass capacitor on resistors as to speed-up slow RCs edges
- 3. Tune Rs on different I2C traces as to guarantee correct SCL arrival time
- 4. Remove all resistors and introduce active protection to avoid short circuiting the CCUs to the FE during power-up
- 5. Remove resistors (same as 1.) and use only one power supply for CCUMs and FE hybrids
- Short circuit I2C (SCL and SDA) lines after protection resistors, thus "equalizing" delay paths to AOH and APVs
