The CMS Tracking Detectors

Joe Incandela

University of California Santa Barbara

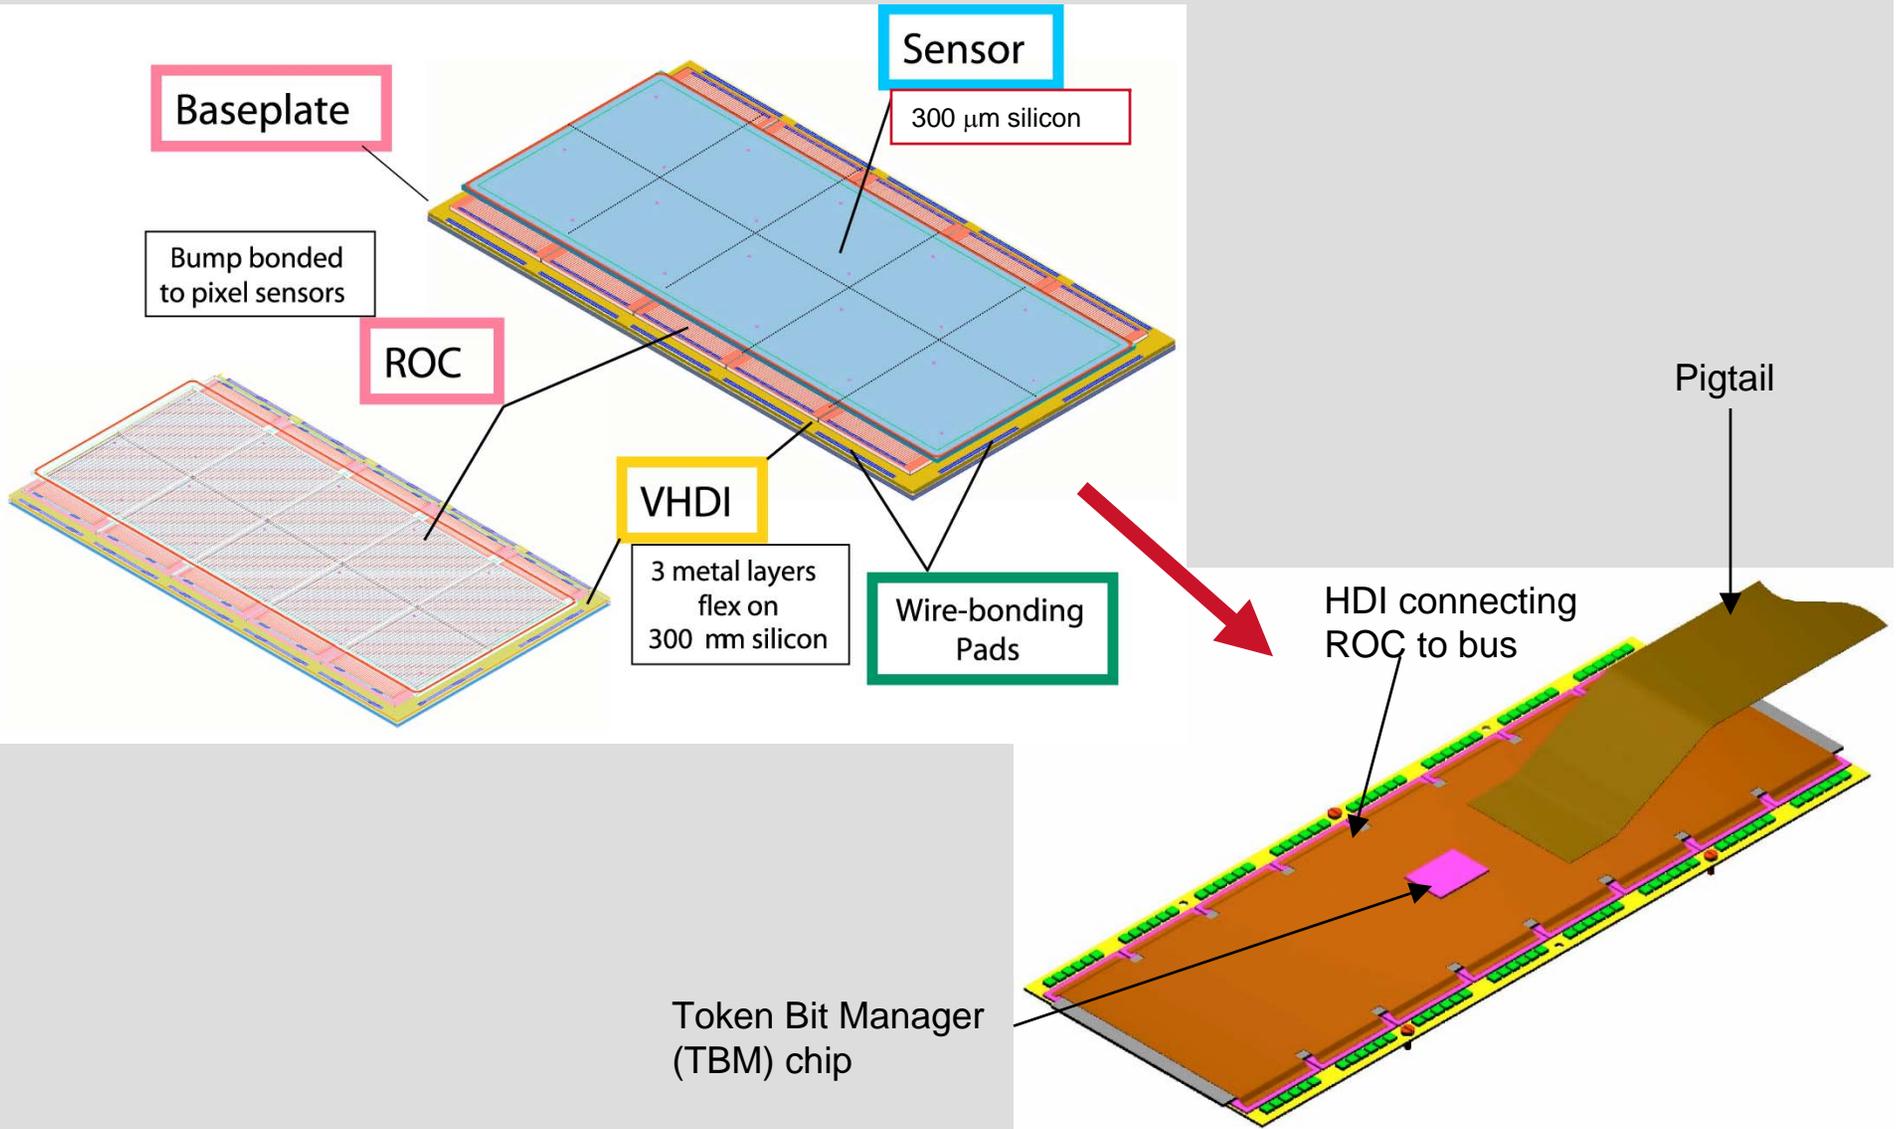
Pixel Barrel Module

CMS Detector Unit

Sensors (300 μm)

- 150 μm x 100 μm pixel
- Oxygenated n+/n with p-stop isolation.
- -10° C operation

➤ Bump bonding

- 25 μm PbSn, Indium
- Failure Rates
 - ~ 1.5 E-6
 - ~ 6E-6 after 50 thermal cycles

➤ Readout Chip (ROC)

- 0.25 μm bulk CMOS
 - Rad-tolerant
 - SEU tolerant
- 40 MHz standard operation

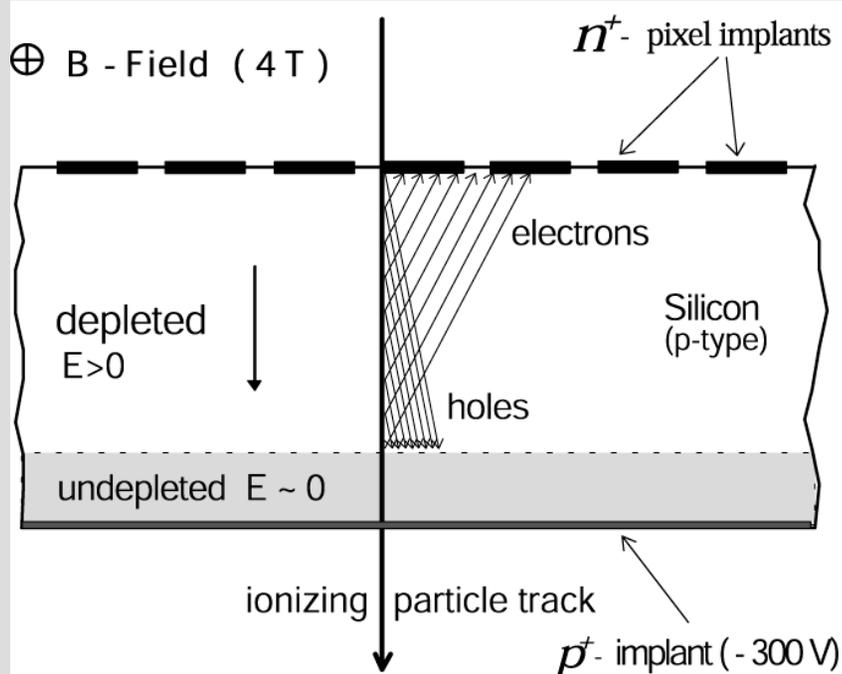
Sensor

➤ Operation

- Collect electrons w/ 34° drift

➤ Radiation tolerance

- Depletion starts at pixels
- Signal/noise high
 - Capacitance ~ 80 fF (~ 500 e)
 - Signal ~ 11000 e per 150 μm

➤ Status

- **CiS** and **Sintef** detectors tested at CERN H2 testbeam ('03) for irradiation fluences up to 10^{15} cm^{-2} .

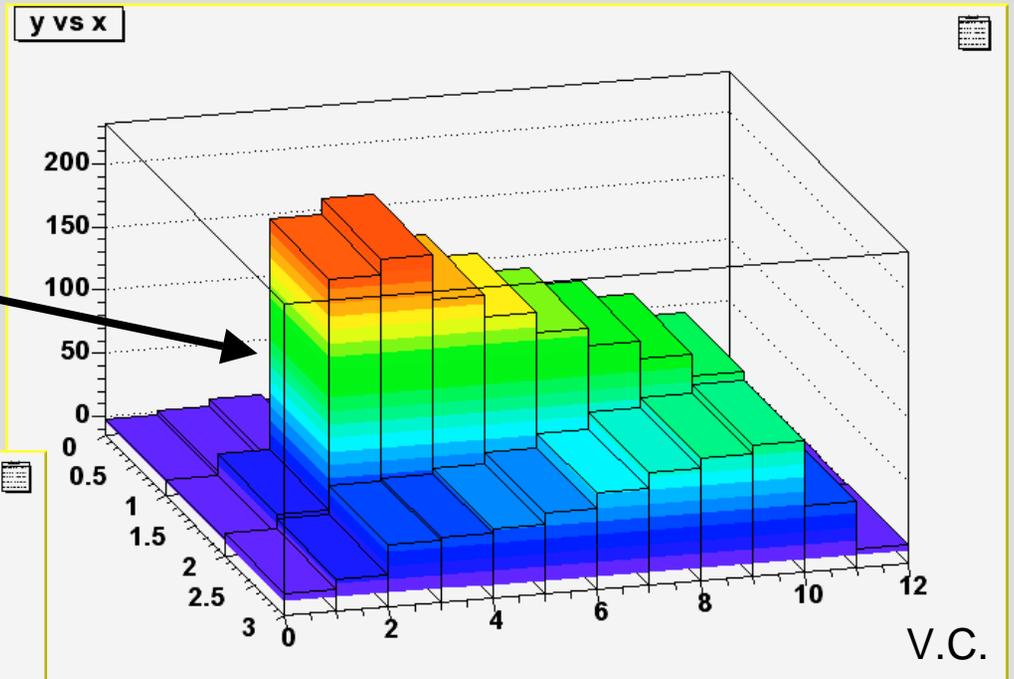
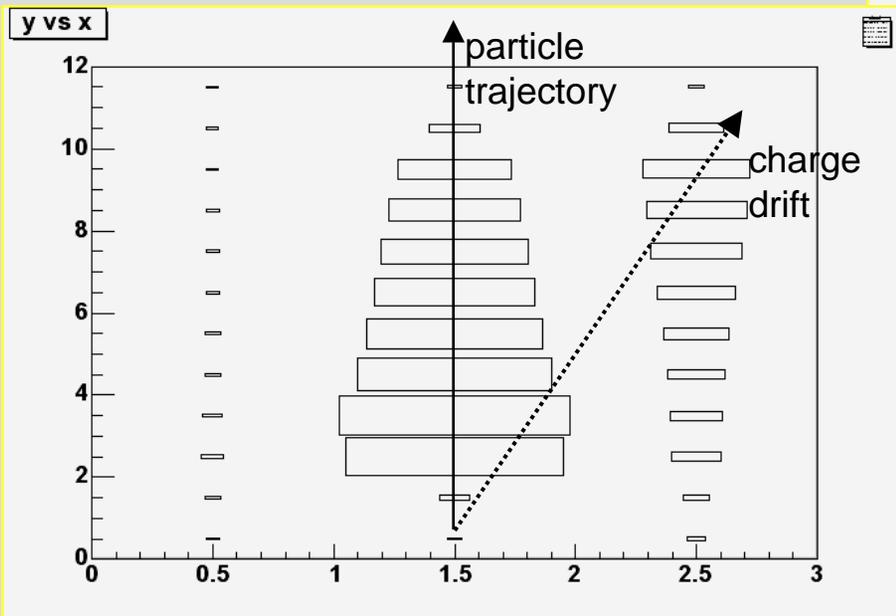
Lorentz Angle

Dot-1 (CiS)
unirradiated
150 V
3 Tesla
15° grazing angle

incoming
particle

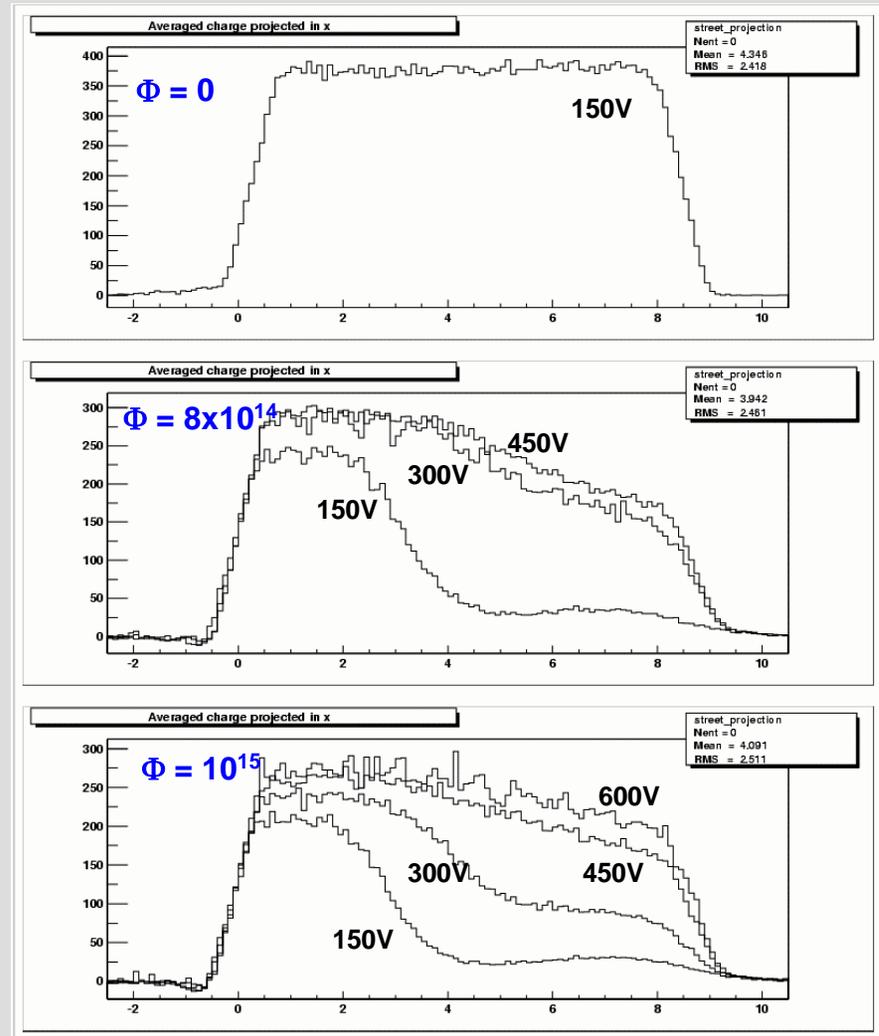
Fluence Limits

➤ Oxygenated CMS pixel sensors

- Double sided, n+ on n – silicon
- 285 μ thickness

➤ Test beam at CERN – 2003

(15° grazing angle of tracks for depletion depth studies)

- Almost fully depleted at 450V!
- See trapping !
- Can likely operate beyond $F = 6 \times 10^{14}$ (assumed in TDR)

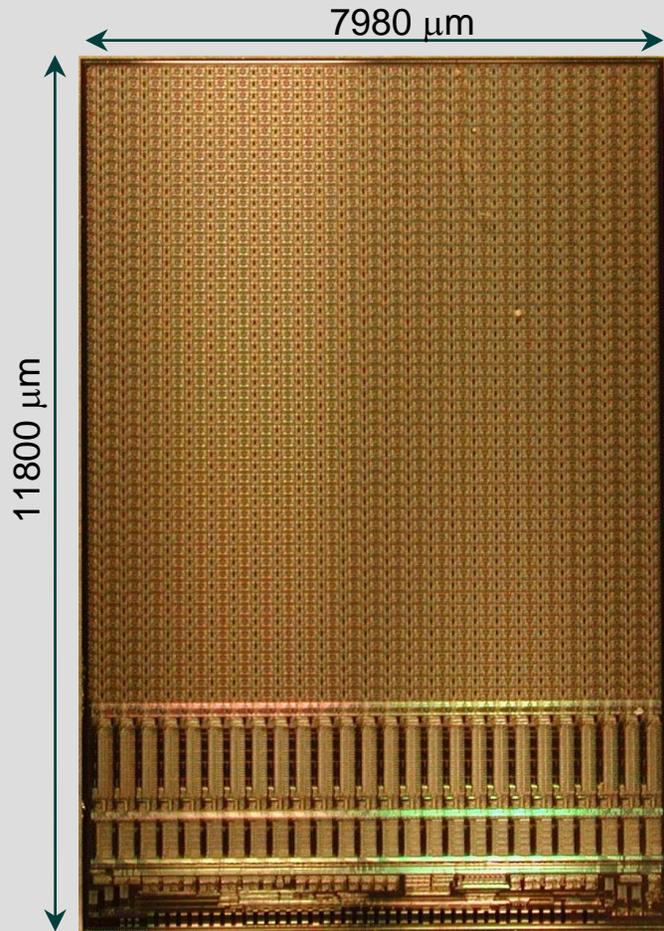
8 wafers of final architecture DMILL received in April 02 work well

52 x 53 pixels of 150 μm x 150 μm , 430k Transistors

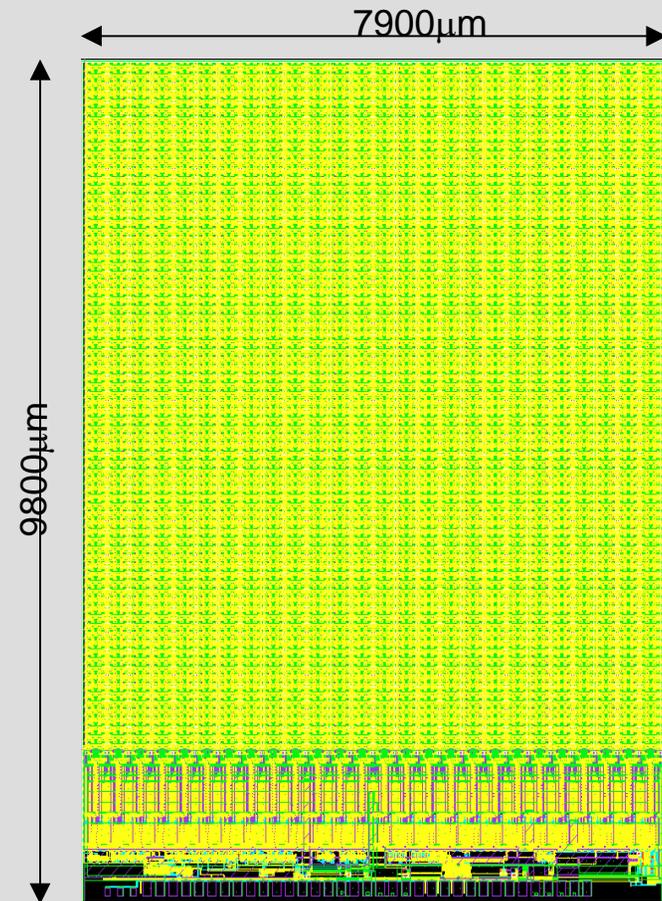
Translation to 0.25 μm started in '02. First chips were produced and work well !

52 x 80 pixels of 100 μm x 150 μm , 1280k Transistors

- Overall judgment : Chip works very well !!!
 - max. operating frequency = 74MHz (68 MHz after 12.4Mrad)
 - Uniformity of address levels is now very good.
 - Chip irradiated to 25Mrad works fine.
 - See shift in band-gap reference (CERN design target was 1Mrad)
 - New Band gap variations designed and under evaluation now
- Low power dissipation: 29 μ W/pixel
 - (cf. 67 and 99 μ W/pixel for ATLAS and ALICE)
- New features
 - Column Drain 3rd hit capability
 - More timestamp & data buffers

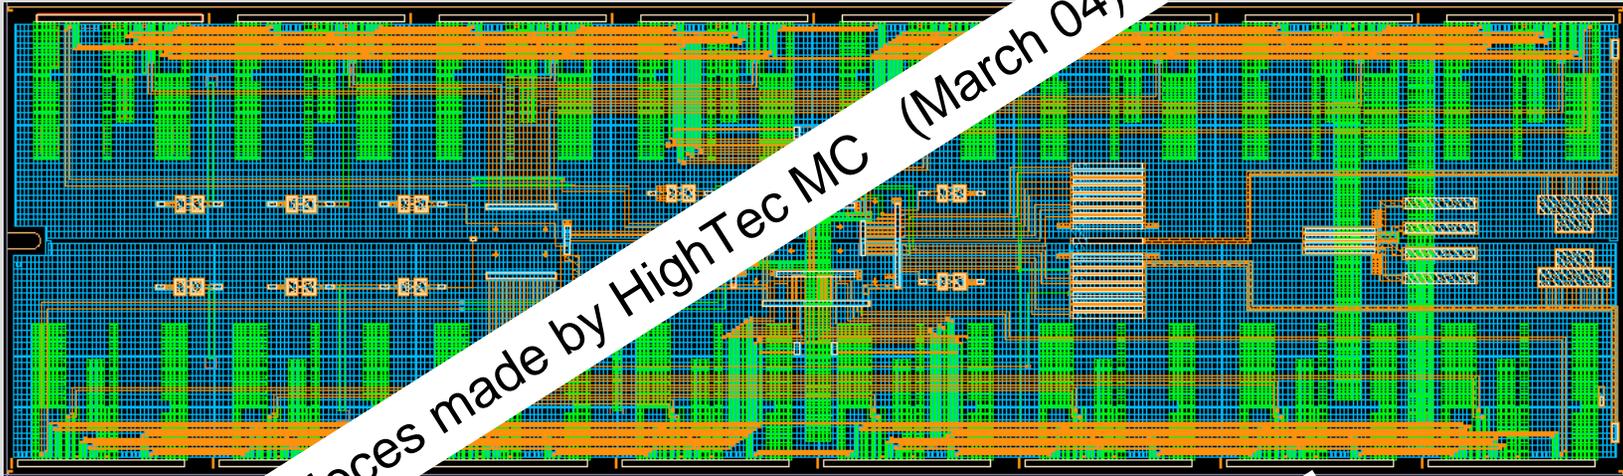
HDI for new DSM Pixel ROC

- 3 layers
- Improve mounting and bonding capability (lesson of 1st iteration)

40 pieces made by HighTec MC (March 04)

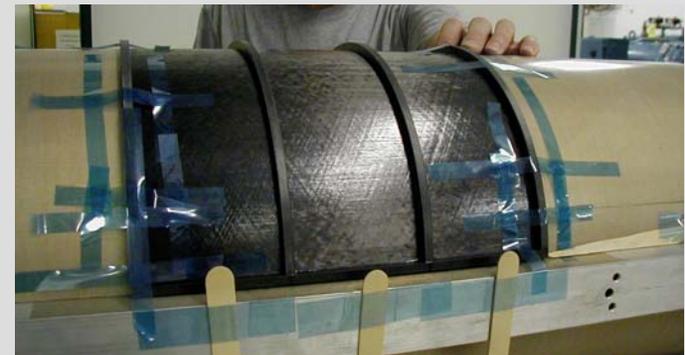
FPix Mechanics (Status May '04)

- Service Cylinder
 - Section assembled, tested, extensive FEA

- Prototype ready by Fall '04
- 1/2-Disk
 - Order prototype by end '04

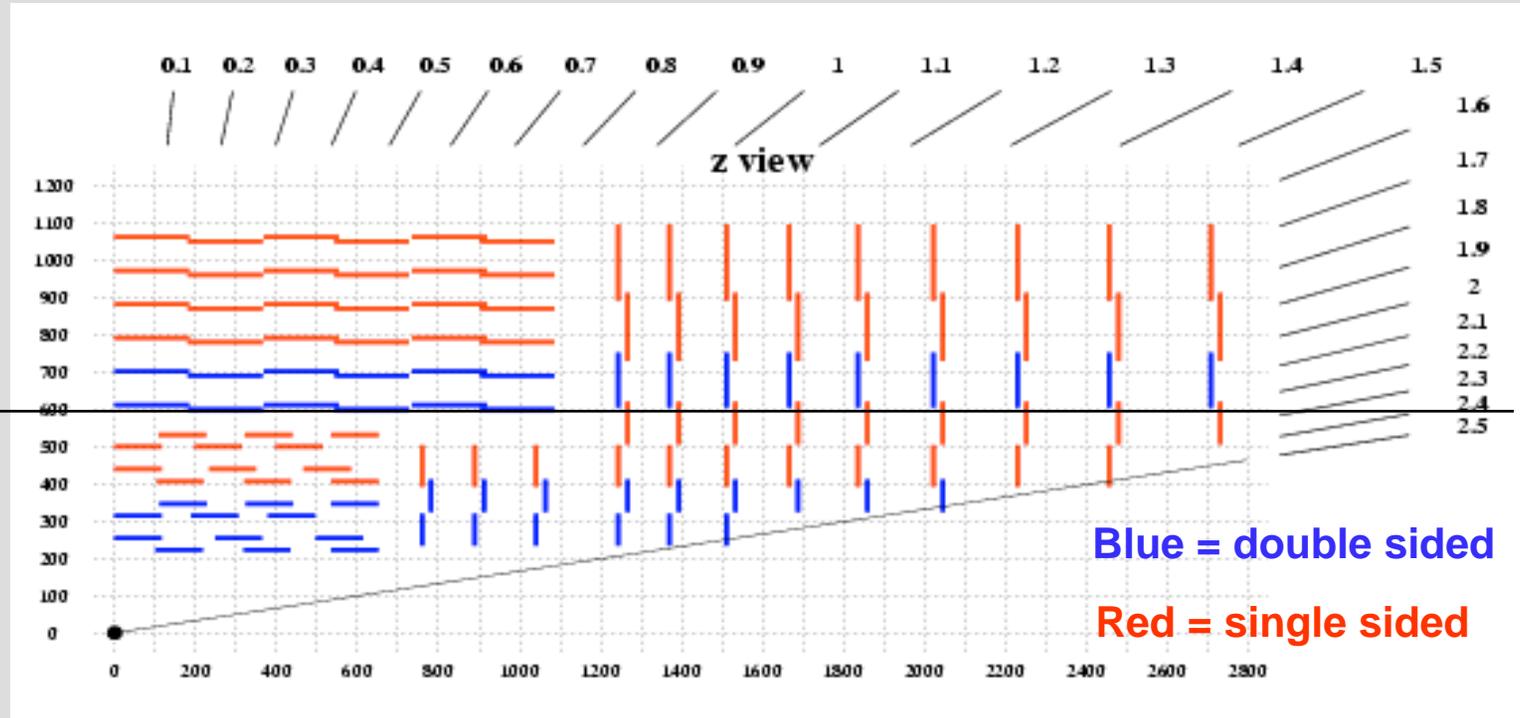
Silicon Strips

500 μm high
resistivity

320 μm thick
low resistivity

Strip lengths **10 cm** (innermost) to **20 cm** (outermost)

Strip pitches **80 μm** (innermost) to **200 μm** (outermost)

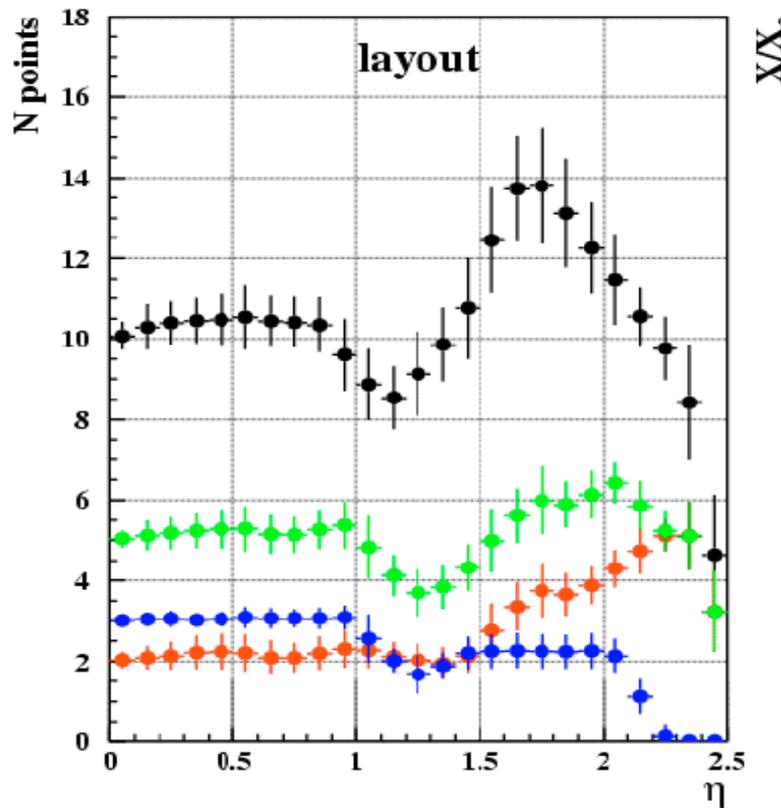
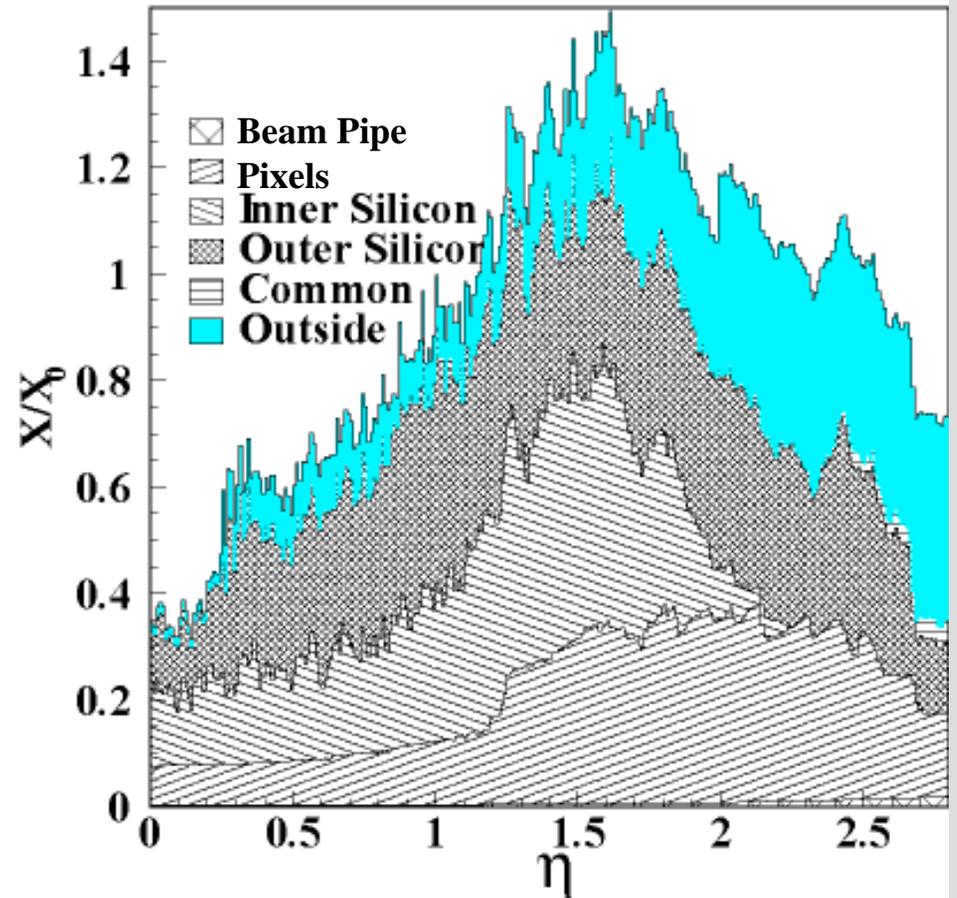
Tracker Coverage & Material!

Tracking layers vs. pseudorapidity:
All, All double layers (axial+stereo),
double inner, double outer.

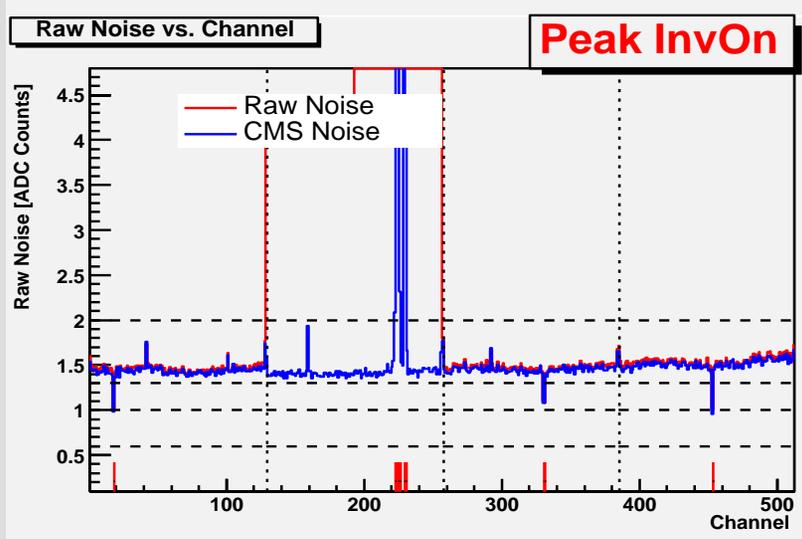
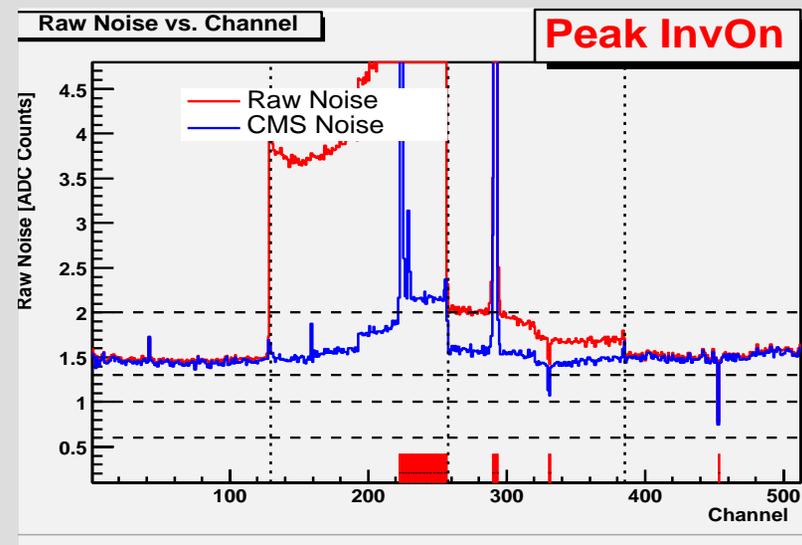
ST Problems: 1.Common Mode Noise (CMN)

CMN effect features:

- Group of noisy strips with a "turn-on" voltage at which all 128 channels show high noise
 - can appear after thermal cycles
 - often accompanied by other types of degradation such as pinhole development, more CMN
- Often correlated with high current

Example: second chip now has a high noise channel which causes common mode noise
Channel previously only had a slightly higher noise (0.3 ADC)

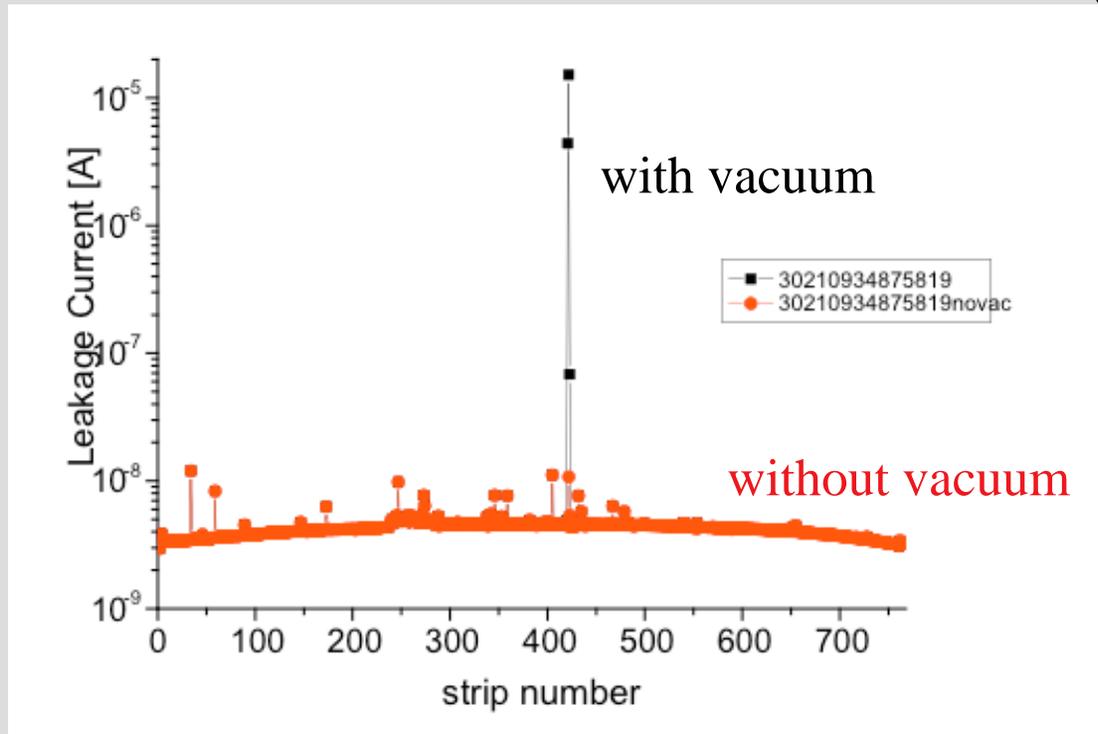
3. Vacuum effect - single strips !

Strip 420 & 421 ($4\mu\text{A}$ $15\mu\text{A}$).

Switching probe chuck vacuum on and off switches these strips on and off.

Effect is reproducible.

No visible defect seen.

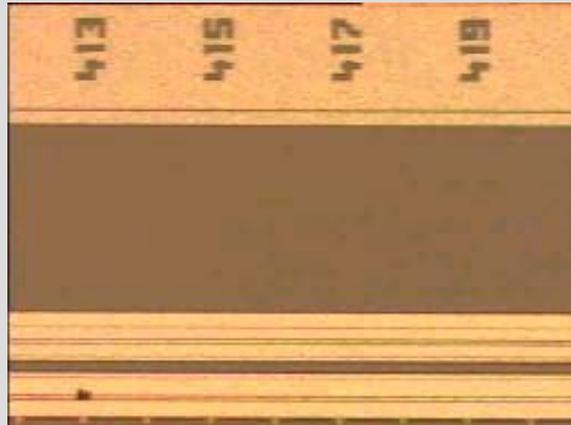
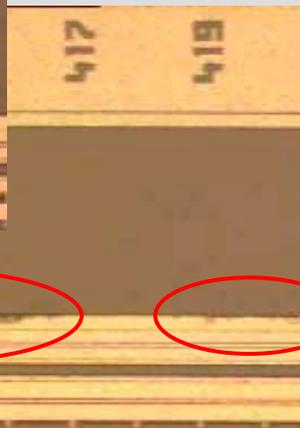
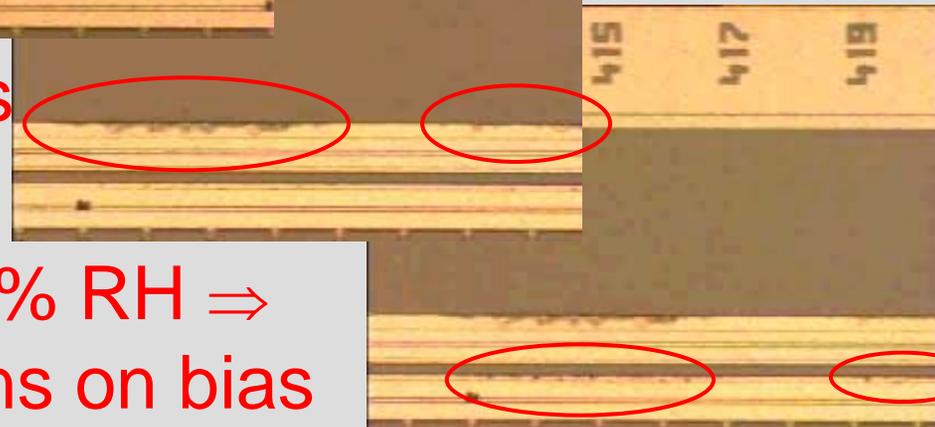
8. "Dots and Stains" development

initial

3 hrs, no hum.
nothing more

30 min, 40% RH \Rightarrow stains
on guard first usually

1h30, 40% RH \Rightarrow
new stains on bias
(not always visible on video, see later)

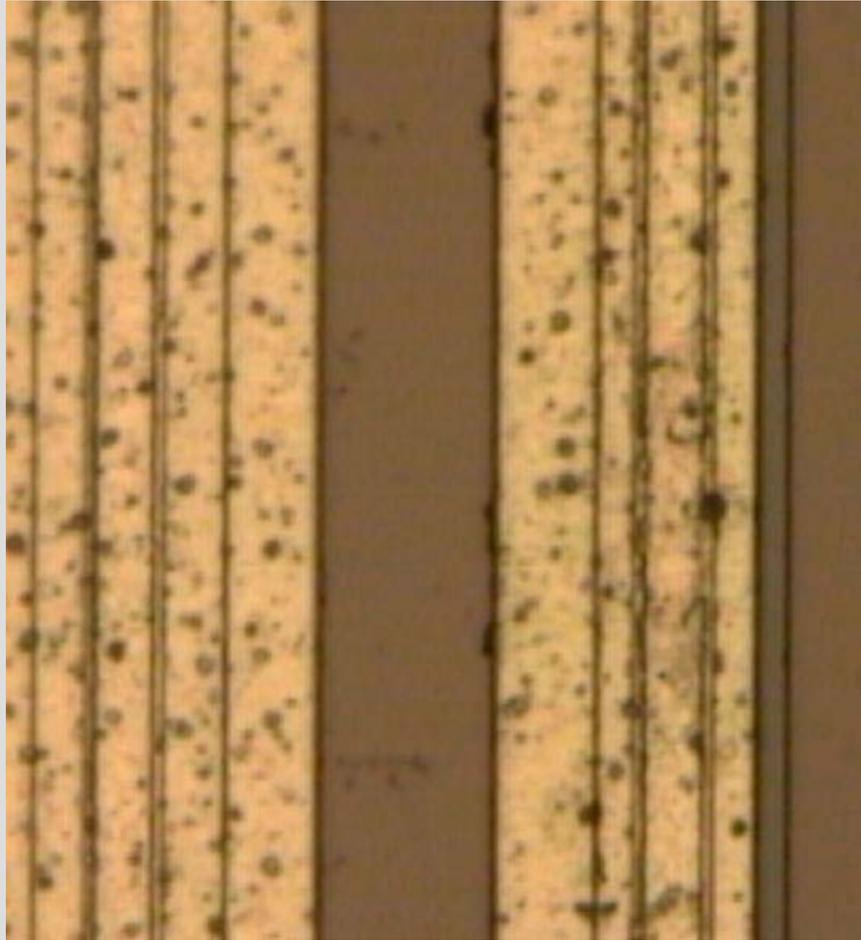
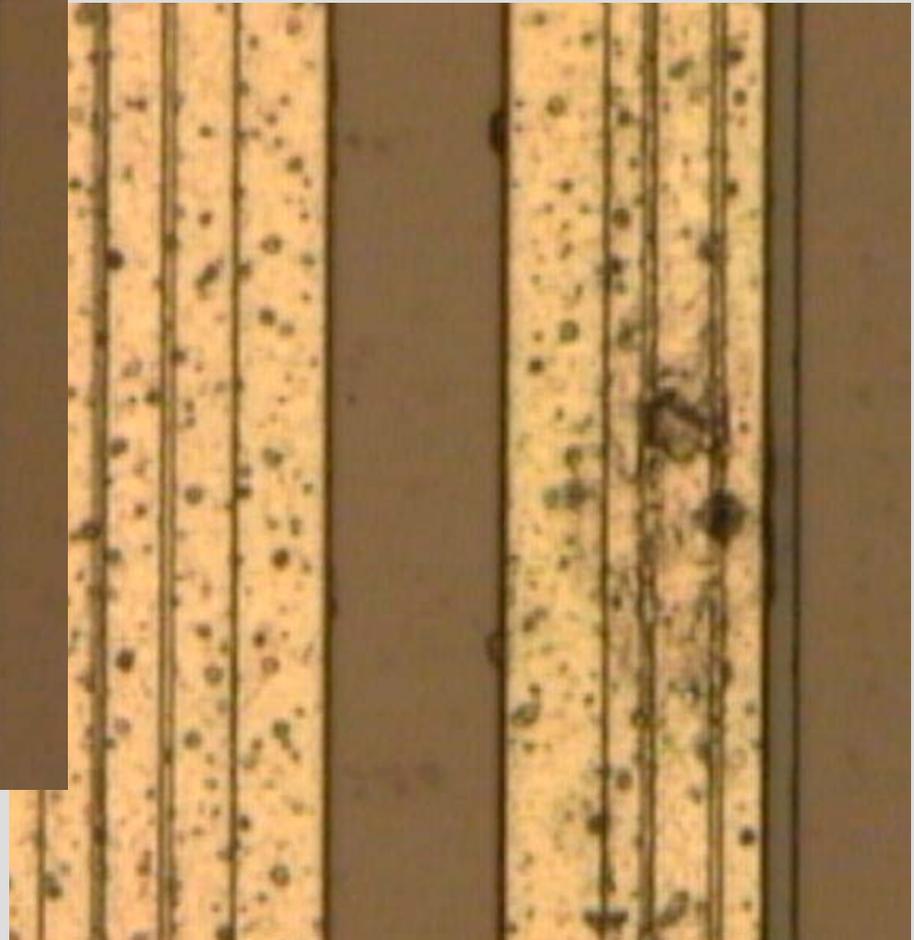
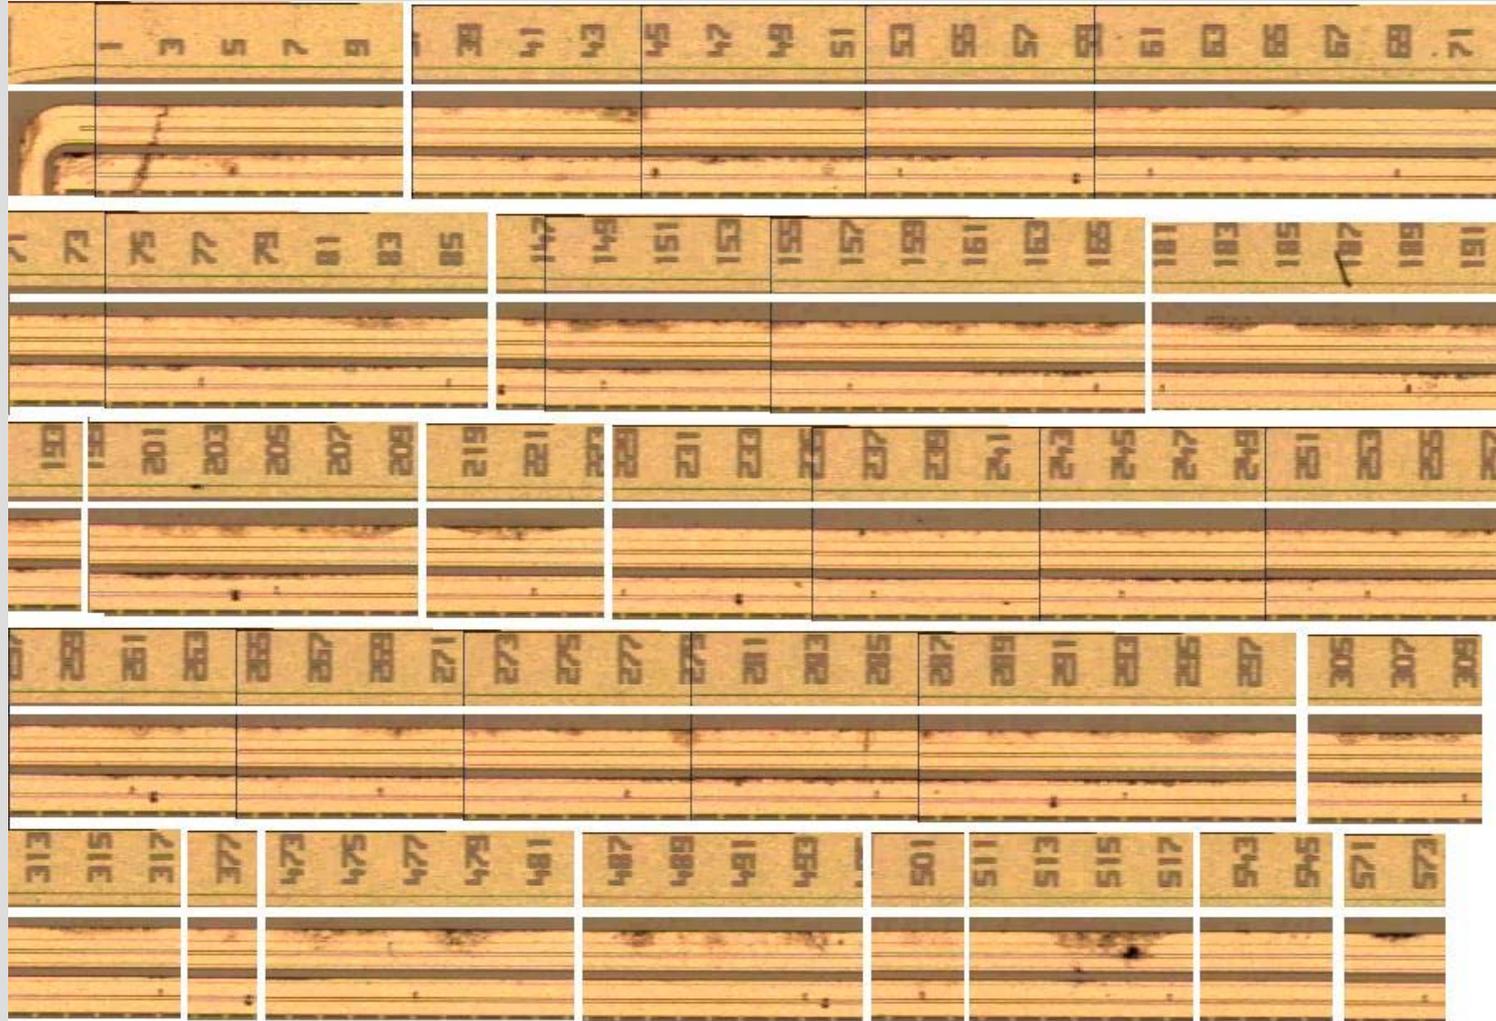
"Dots and Stains" development

30 min, 40% RH

1h30, 40% RH

example shown here: 30% of the length affected!

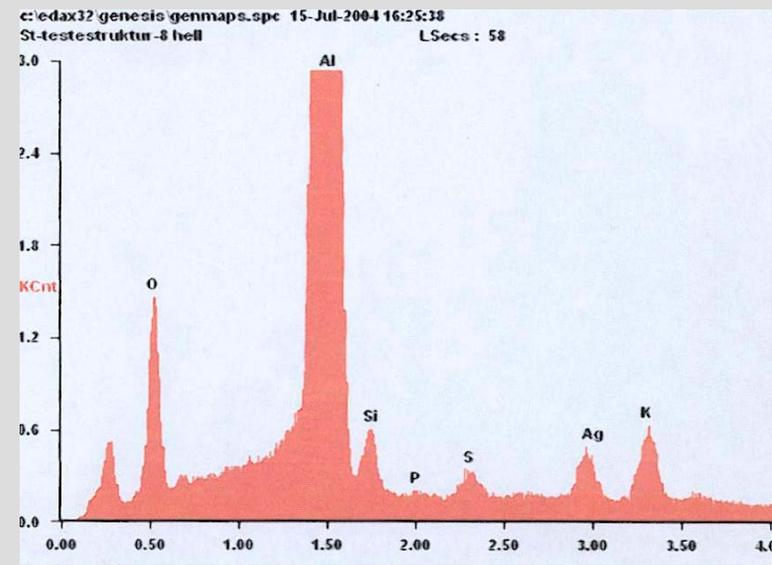
"Dots and Stains" origin

Investigation by Strasbourg and Karlsruhe
(with help of the Fraunhofer Institute Chemische Technologie)

The ratio of elements in white areas of stains indicates the existence of Aluminum-oxide

Corrosion !

Element	Wt%	At%
O K	15.64	24.31
AlK	78.20	72.07
SiK	01.88	01.67
PK	00.25	00.20
SK	00.58	00.45
AgL	02.19	00.51
KK	01.26	00.80

Both dots and stains are **micro-corrosions** of the aluminum surface. The mechanism that drives this phenomenon can be the following:

Humidity reacts with Phosphorus (present in a 4% concentration into the passivation oxide) and forms an acid (probably H_3PO_4), that corrodes a superficial layer of Aluminum.

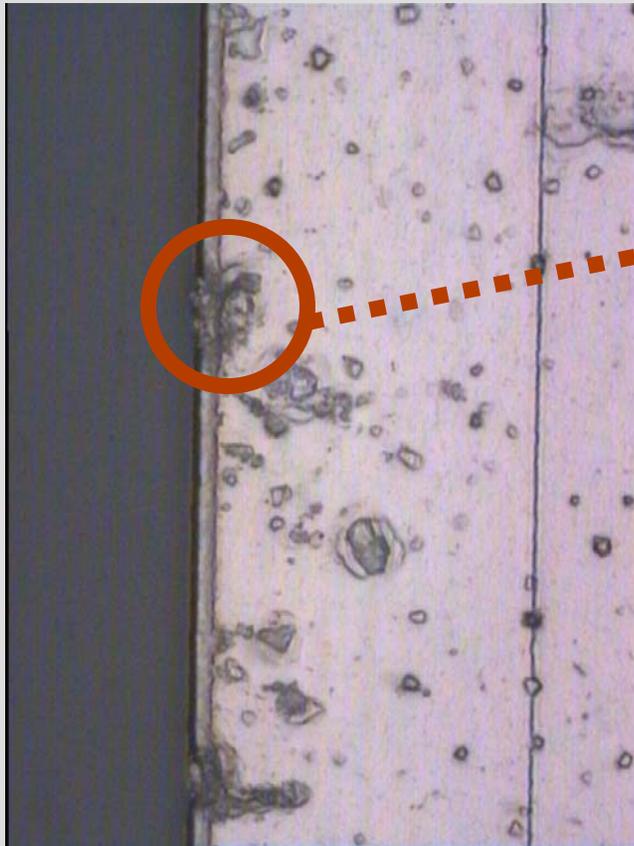
2 sensors were sent to ST together with corresponding pictures of 'dots and stains'

View by optical
microscope

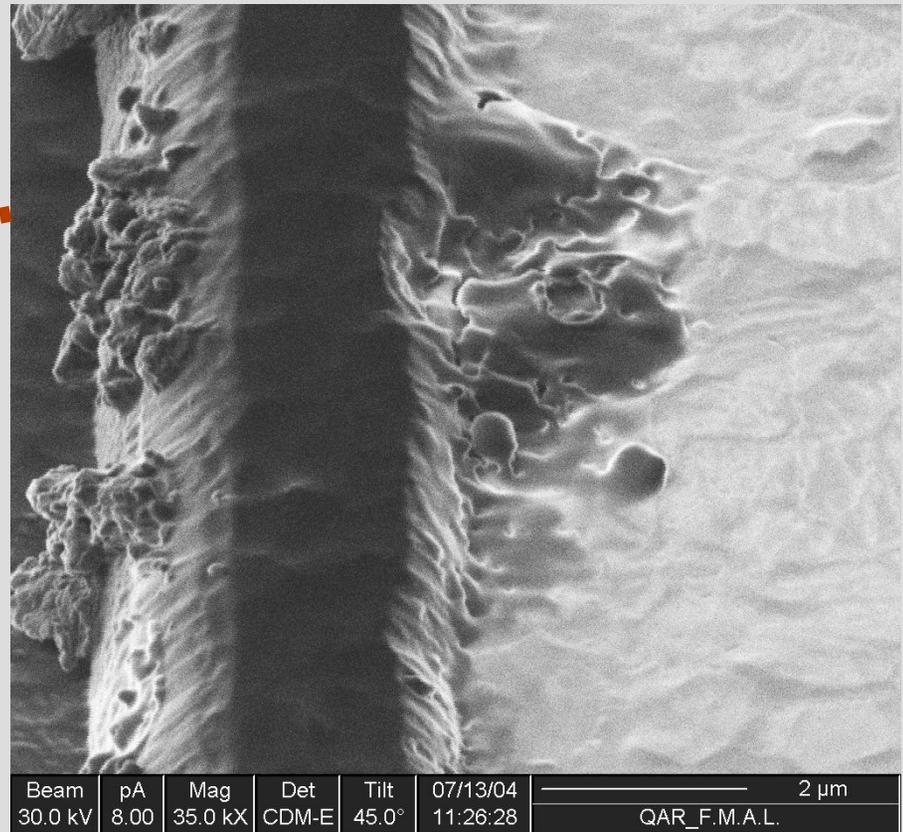
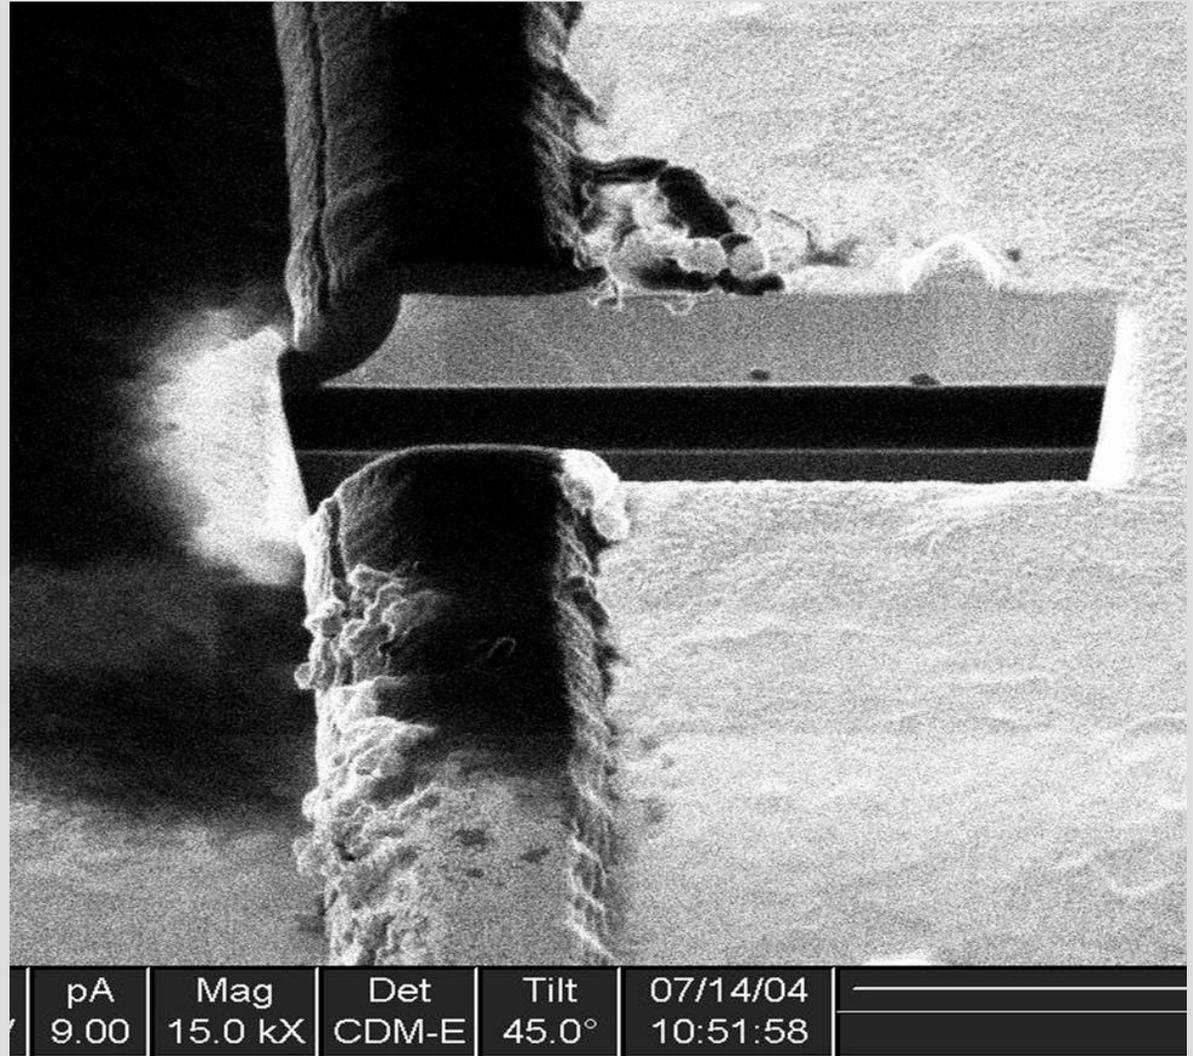
Focused ion beam (FIB)
microscope

Cut by ionic beam & cross section viewed via FIB

Cut line

Cross view (FIB)

Close-up

Aluminum corrosion

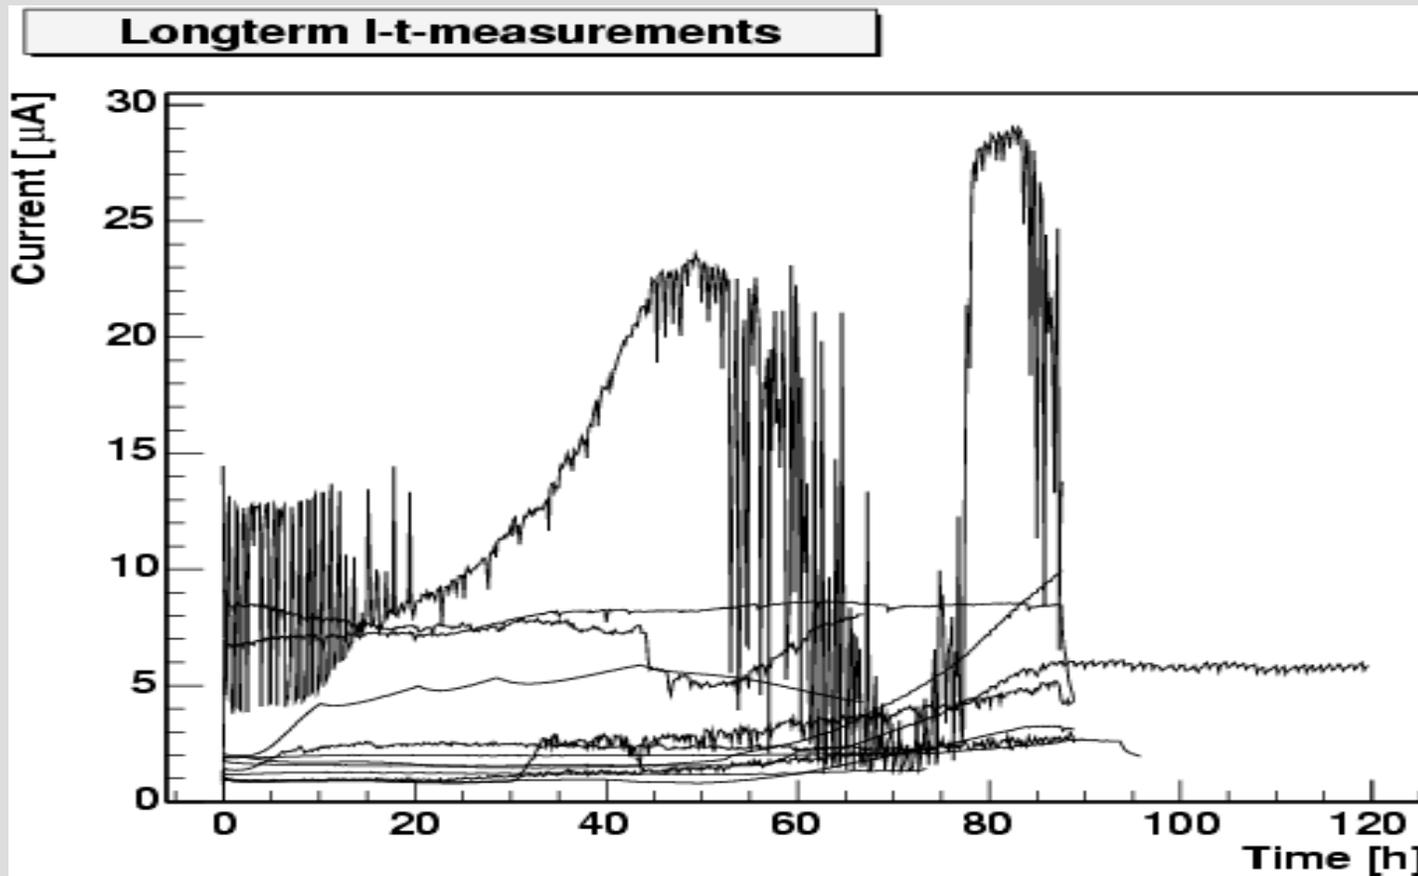
Longterm tests of “Qualification Sensors” show continuing instabilities

○ 233 sensors tested 72h (room temperature, r.h.=25-30%)

Failure rate of qualification sensors in 72 h period is 5%

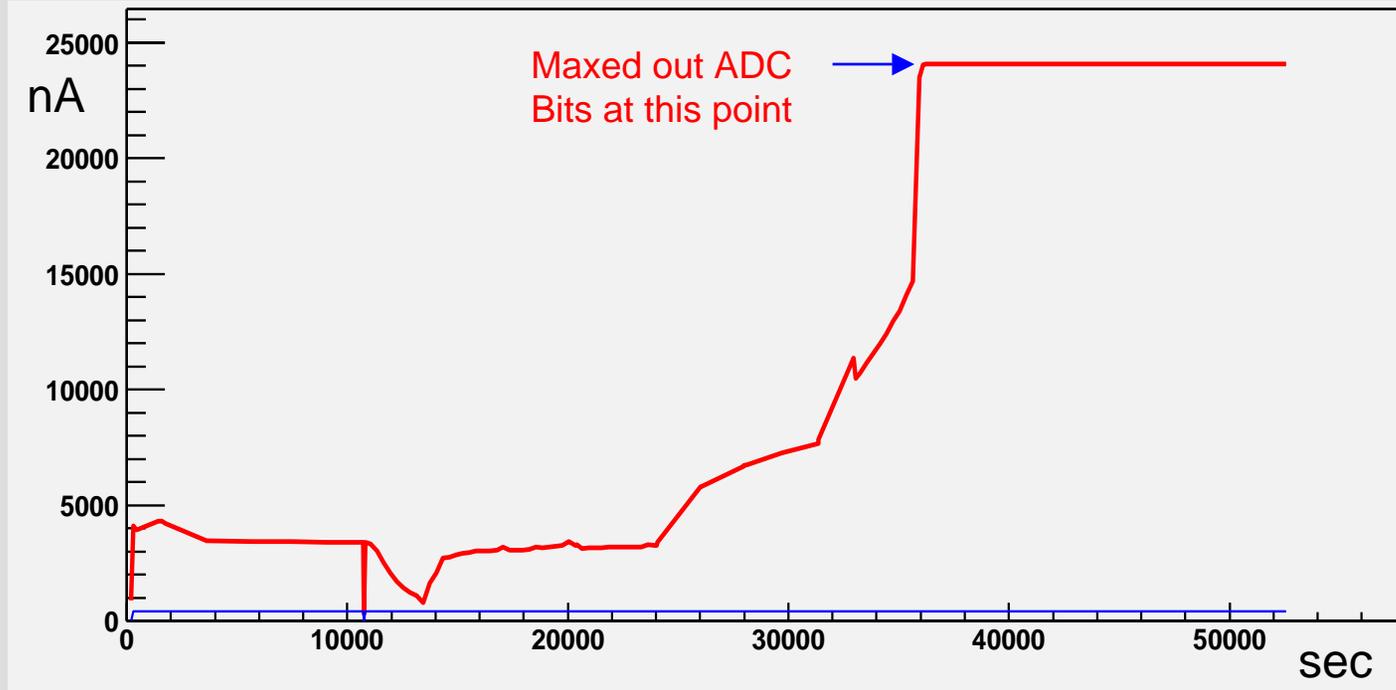
9. Modules that deteriorate

- Module 5379: After 7 hours, bias current of module started to increase
- Post LT test reconfirmed current increase
 - New high noise channels seen in subsequent tests
