The CMS Tracking Detectors

Joe Incandela

University of California Santa Barbara

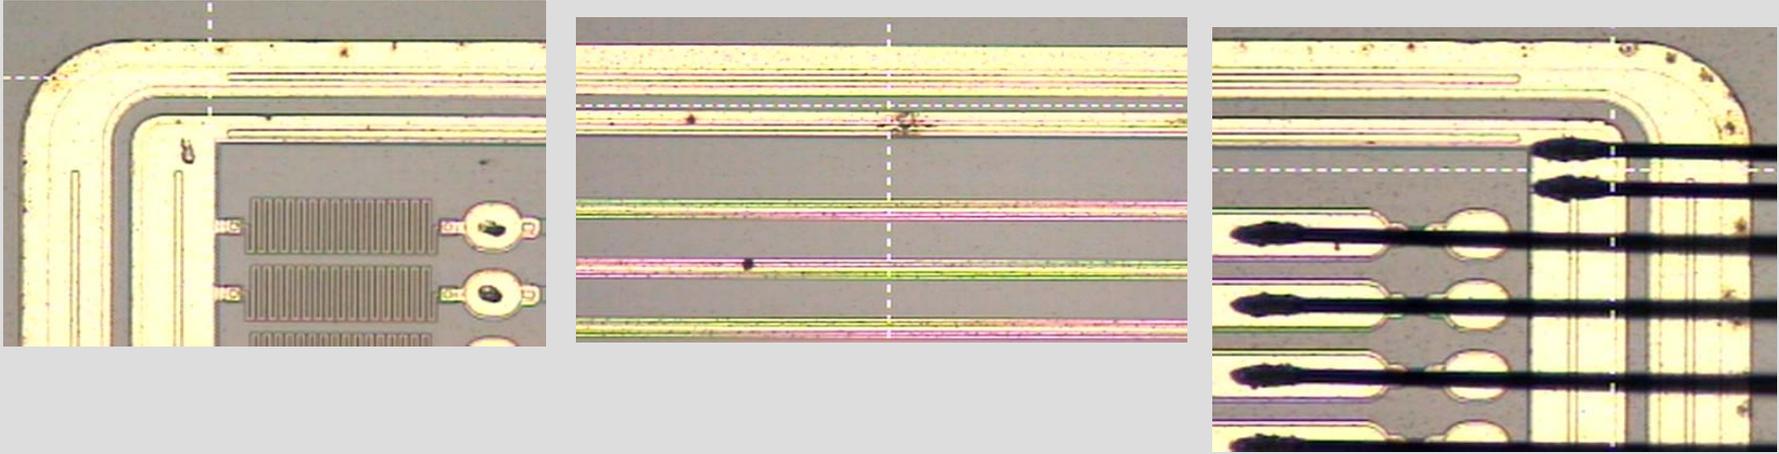
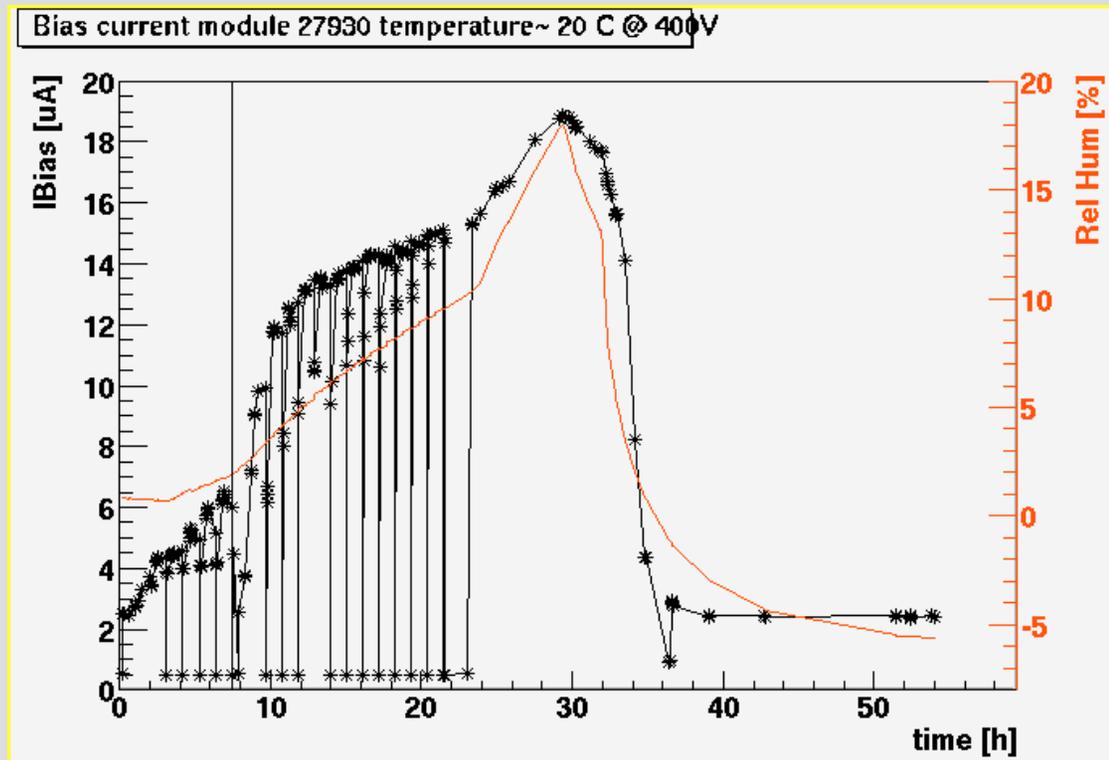
Longterm Module Failure

➤ Dark marks on bias ring occur near high noise channels

Results from TEC Modules

22 modules tested

1 module with current increase during LT test

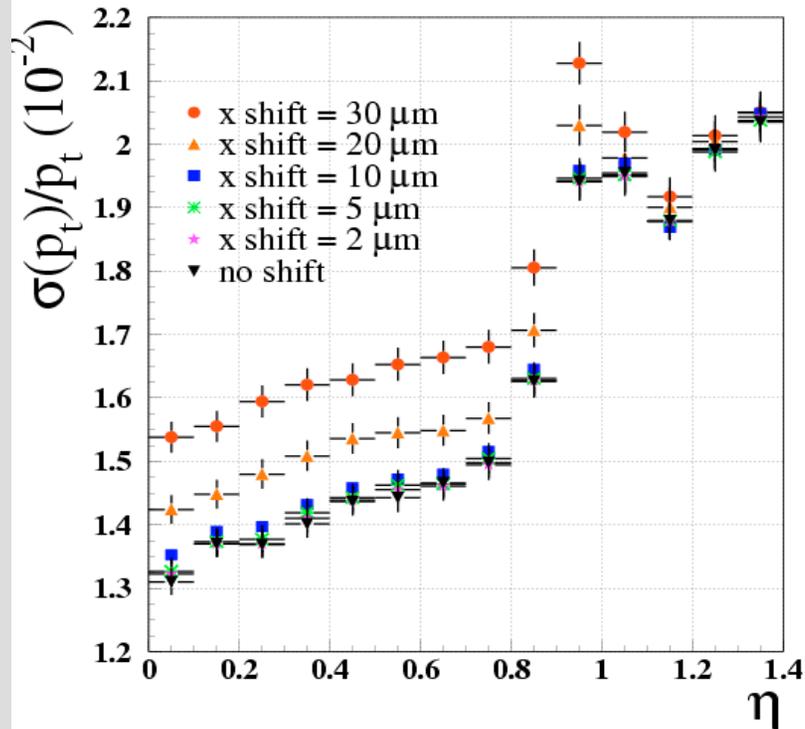
Misalignments and P_T Resolution

MC Study of effect of misalignments
on p_T resolution:
single μ sample, $p_T = 100$ GeV

Mean 0.0
RMS 3.5 μm
Min -7 μm
Max +7 μm

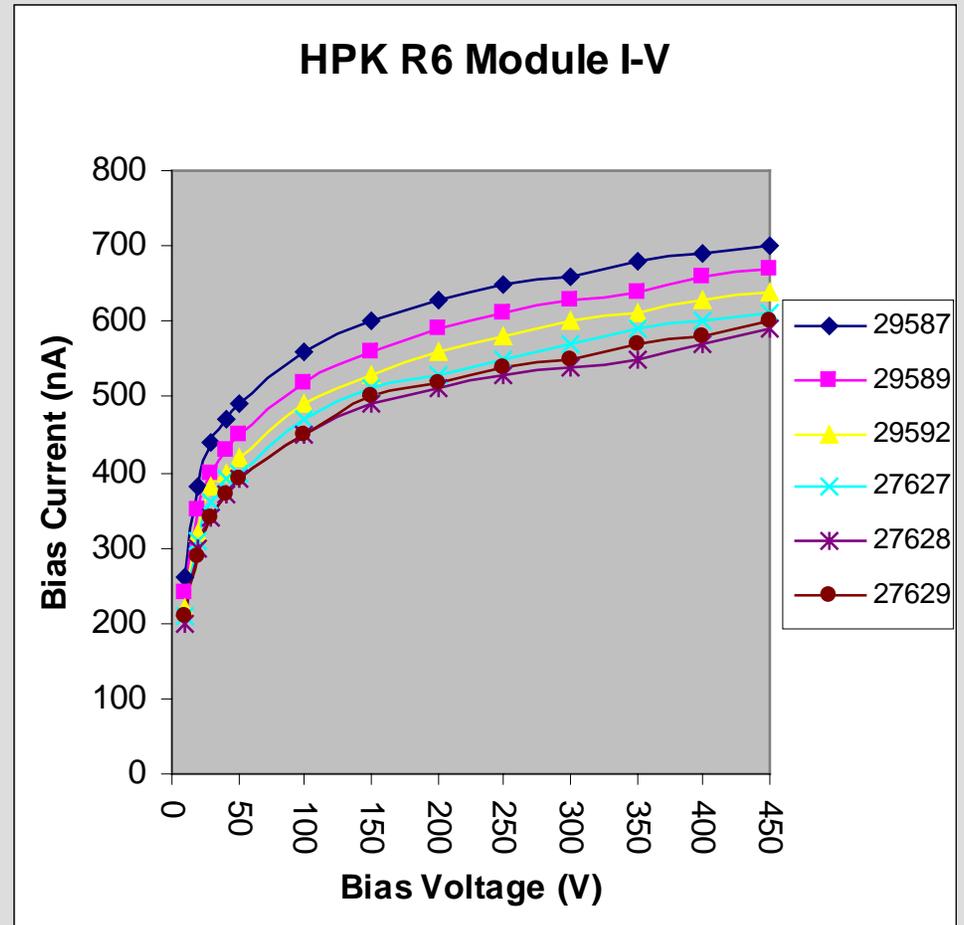
First HPK Module Results From UCSB

6 R6 modules built using new HPK sensors

IV profile as expected

- Turn-on at low voltage
- Plateau bias current ~ 600-700 nA

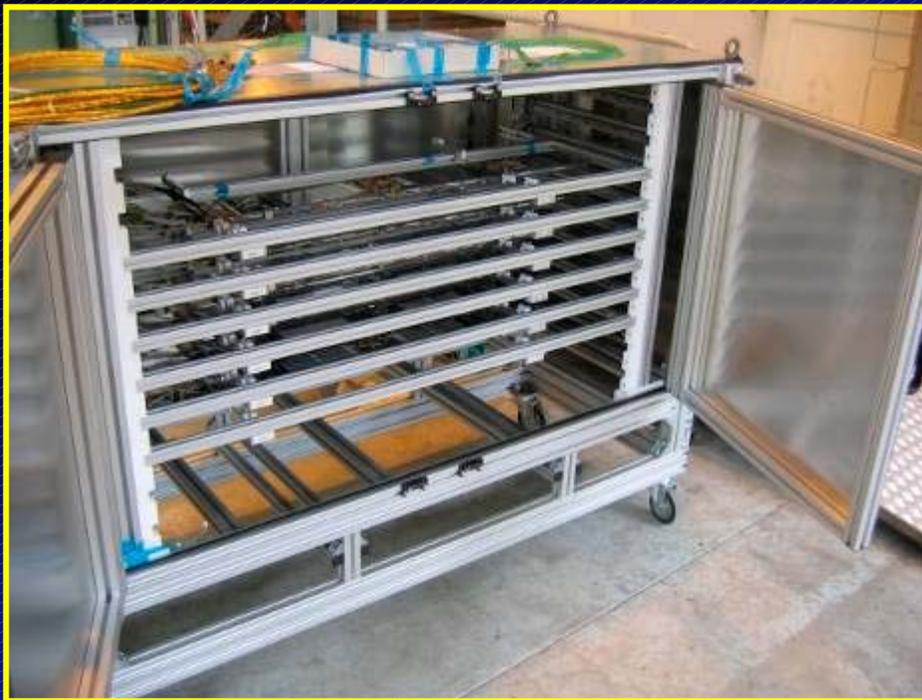
The TOB Cosmic rack in the test beam in June 2004

- May 2004 Beam Test
 - Multiple rods, petals, and shells
 - Larger system integration tests
 - Tracking tests
 - Position resolution, hit efficiency

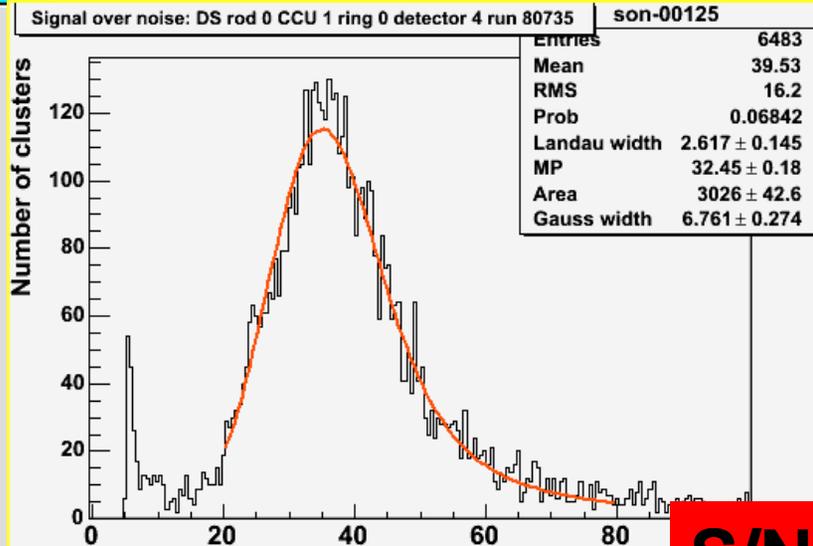
S/N Module 4 @ 300V (PEAK)

S/N > 32

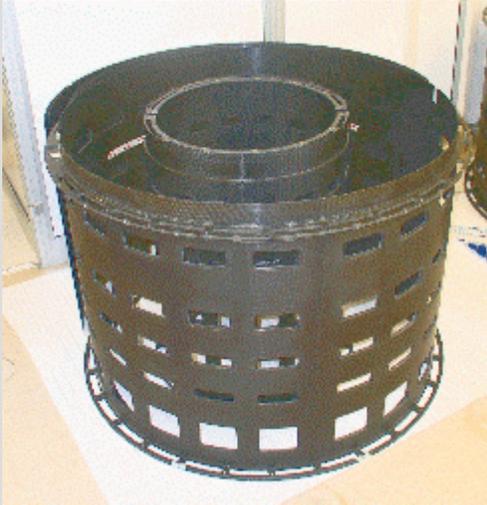
Mechanics: Tracker Inner Barrel

Support mechanics :
CF space frames
and/or Honeycomb
structures

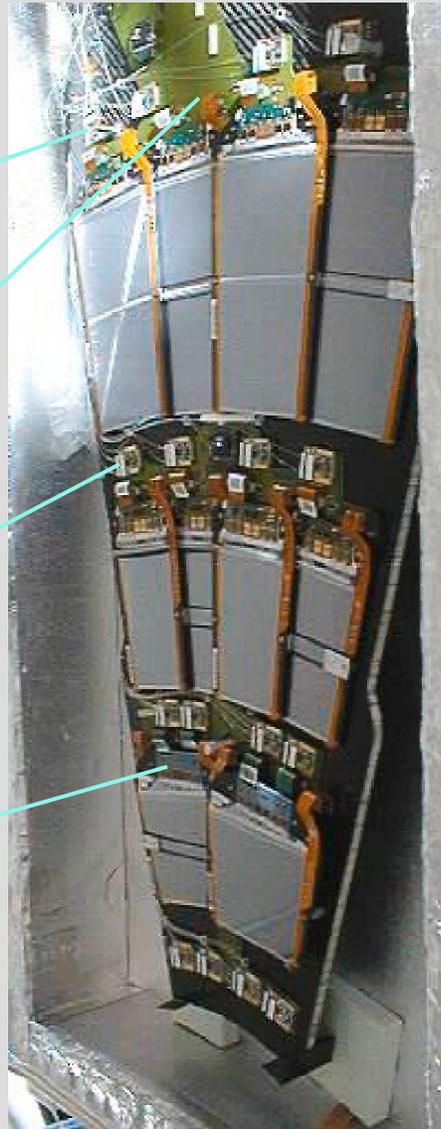
Mechanics: Tracker End Caps

Digital
Optical
Hybrid

Interconnect
Board

Analogue
Optical
Hybrid

Frontend
Hybrid
